Inappropriate shock and battery switching to “End of Life” in a patient with biventricular ICD during magnetic resonance imaging

İlyas Atar, M.D., Uğur Bal, M.D., Çağatay Ertan, M.D., Bülent Özın, M.D., Haldun Müderrisoğlu, M.D.

Department of Cardiology, Baskent University Faculty of Medicine, Ankara, Turkey

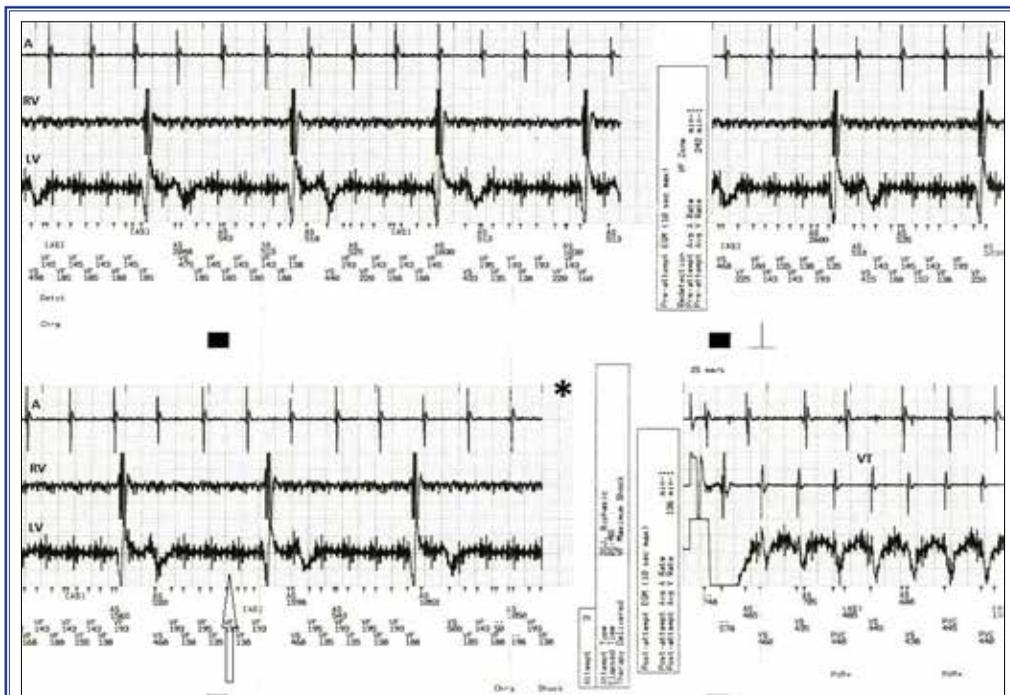
An ICD assessment was performed the following day. Following interrogation, a screenshot displaying “End of Life” (EOL) appeared and was followed by another screenshot displaying “General PG Fault.” Interrogation of the stored electrograms revealed electromagnetic noise superimposed on normal sinus rhythm that was detected as ventricular fibrillation, and the ICD could not sense the atrial signals due to the electromagnetic effect. During the second sequences of MRI, the capacitors were charged 3 times, but no therapy was delivered in the first 2 attempts. In the final attempt, a 31 J shock was delivered (Figure 1). During interrogation, the final capacitor re-form was reported 3 days prior to MRI, with a battery voltage of 2.78 V. The impedances of atrial, right ventricular, left ventricular, and shock leads were 529, 914, 1076, and 41 ohms, respectively. At the first interrogation, the heart could only be paced via the left ventricular lead, and there was a sudden drop in battery voltage from 2.78 V to 2.69 V. Under temporary pacemaker, the patient was taken to the electrophysiology lab, where the capacitors were reformed twice. Following reformation of the capacitors, battery status

Figure 1. Electromagnetic noise superimposed on sinus rhythm detected as ventricular fibrillation. Detection, redetection and therapy delivered (31J biphasic shock) during MRI. The marker channels are on top, A: Atrial; LV: Left ventricular; RV: Right ventricular. The electrograms A, RV and LV are below the marker channels. Arrow: Electromagnetic noise that detected as ventricular fibrillation. *: Time of 31 joule shock that delivered to obtain sinus rhythm. VT: Non-sustained ventricular tachycardia after shock delivered.

indicator returned to normal, and the EOL indicator disappeared. As the patient was a sudden death survivor, had received appropriate shocks in the past, and was pacemaker-dependent, the decision was made to replace the ICD battery. No dislocation of the lead or injury to the pocket was observed.
