Damages and failures observed in infill walls of reinforced concrete frame after 1999 Kocaeli earthquake

Serkan YATAĞAN

Istanbul Technical University, Faculty of Architecture, Istanbul, TURKEY

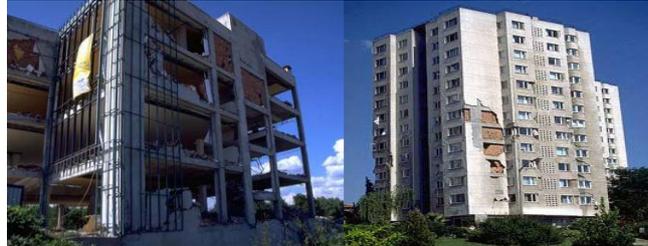
frame-infill wall system [Sezen 2002 *et al.*]. In Figure 2, the complete and partial damage to hollow clay tile walls in four and thirteen-storey buildings, respectively are seen. The four-storey building was under construction at the time of the earthquake; the thirteen-storey building was constructed in the early 1970s.

Figure 2. Varying degrees of damage to infill walls

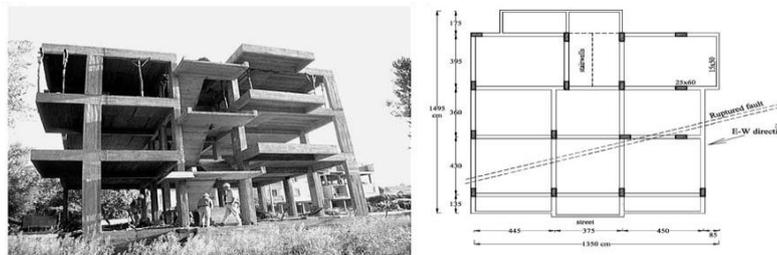
Residential buildings in the epicenter region typically range in height from two to seven storeys. Fig. 3a shows a photograph of a three-storey moment resisting frame building that was under construction at the time of the earthquake. A plan of the second floor is shown in Fig. 3b. The column orientations and locations are such that all of the moment-resisting frames include one or more columns with their weak axis perpendicular to the frame direction. These observations, which were typical of most buildings in the epicenter region, would suggest that the framing system is much stiffer and stronger in the direction perpendicular to the street assuming that similar rebar are used in all beams and all columns. Such framing likely possesses limited strength and stiffness, which if coupled with non-ductile reinforcement details, results in a vulnerable building in the event of earthquake shaking.

Figure 3. Damage in the building due to the irregular axes

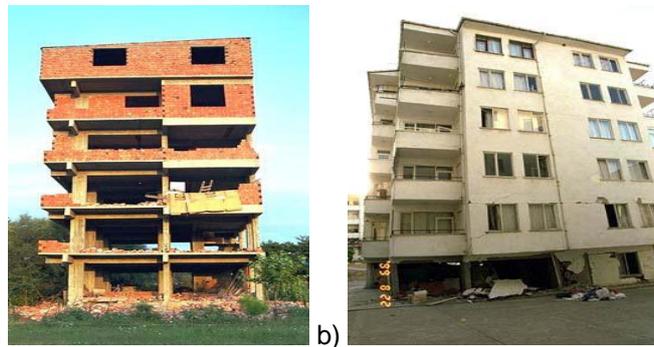
Damage to infill masonry walls was concentrated in the lower stories of buildings because of higher demands on the strength of the moment-frame-infill wall system. In Figure 4, the distribution of damage to infill walls in two buildings, one near Golcuk, and one in Degirmendere are illustrated. In these buildings, the lateral stiffness of the infill walls is likely of the same order or greater than that of the moment-frames. For these buildings not to collapse following the failure of the infill walls the moment-frames must have possessed significant strength and some limited ductility.

Figure 4. Damage to infill masonry walls in Golcuk (a) and in Degirmendere (b)

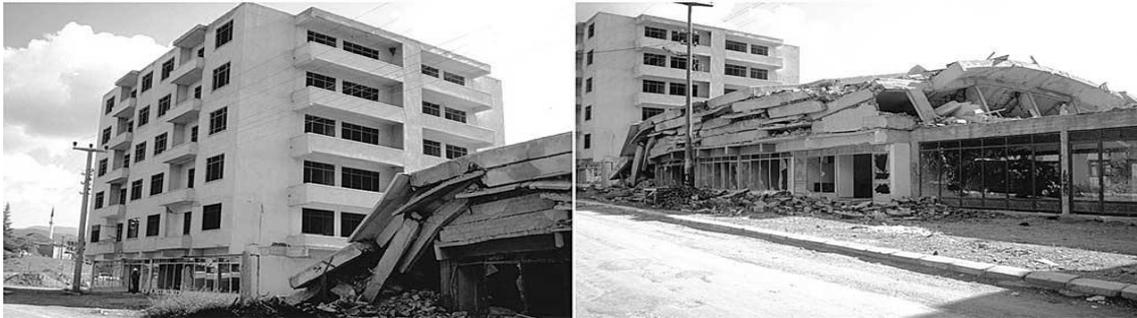
Figure 5 shows two six-storey non-ductile moment-frame buildings in Golcuk. One of the buildings collapsed completely, whereas the adjacent building exhibited shear cracks in the first storey. Both buildings were likely subjected to similar levels of earthquake shaking, yet one building performed well, while the other collapsed. This raises many questions regarding the limit state for non-ductile moment frames. Small differences in the strength of these non-ductile buildings possibly caused by the variation in material strength, construction practice, and workmanship could account for the drastic difference in performance.

Figure 5. Damages in two six-storey non-ductile moment-frame buildings in Golcuk

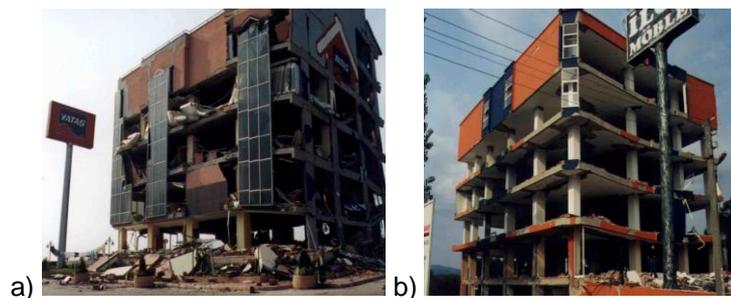
Lateral bracing for reinforced concrete frame structures was provided by brick and (or) concrete masonry walls. The brick masonry was often in the form of the hollow architectural blocks. During the earthquake, these walls were able to participate in lateral load resistance to varying degrees and were often damaged prematurely, developing diagonal tension and compression failures or out-of-plane failures. The degree of lateral load resistance depended on the amount of masonry used and the framing system provided. In contrast to modern moment resisting frames of North American practice, the use of light partitions, such as dry walls, was not common in the earthquake-stricken areas. Instead, masonry was used extensively for interior partitioning, as well as exterior enclosure of buildings, increasing wall-to-floor area ratios. Therefore, in spite of lower strength and expected brittleness of this type of masonry walls, the frames did benefit somewhat from such extensive use of masonry until the threshold of elastic behavior was exceeded. Beyond the failure of brittle masonry, there was no lateral load resisting system with sufficient stiffness to control lateral drift, thereby resulting in high drift demands on the frame members. Figures 6 and 7 reveals different degrees of masonry failure, resulting in partial damage, severe damage, and collapse of the frame structure [Saatcioglu, 2001 *et al.*].

Figure 6. Showing (a) extensive damage in masonry infilled walls with no apparent distress in concrete frames (b) complete collapse of masonry infilled walls with some distress in first storey columns

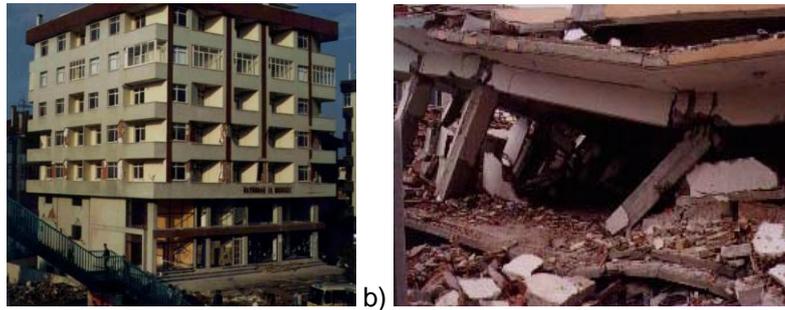
During the seismic response, the failure of brittle masonry walls placed a heavy demand on the first-storey columns of multi-storey buildings. The columns sustained heavy damage mostly because of lack of sufficient transverse reinforcement. The transverse reinforcement consisted of 8 mm diameter smooth reinforcement, generally placed at 300 mm or wider spacing. The infill walls suffered brittle failures and increased the base shear level, demonstrating that non-ductile frames with brittle infill walls are poor lateral load resisting systems for earthquakes [Saatcioglu, 2001 *et al.*].

Figure 7. Showing (a) very limited damage to infill, (b) complete structural collapse including the infill.

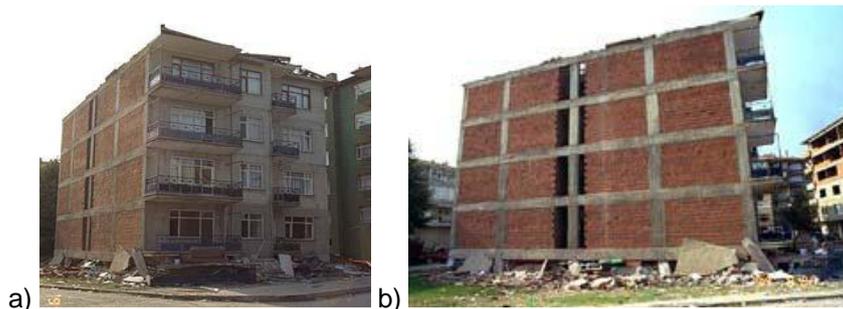
In Figure 8, the views of a collapsed apartment building in Golcuk are seen. The first two storey of this building failed completely, but damage in the upper four storey with unbroken glass windows was limited. The long infill walls in the upper four storey have significant elastic strength and stiffness probably much greater stiffness and strength than the moment-resisting frame. The brittle fracture of the first and second storey infill walls prior to flexural yielding of the columns would have overloaded the brittle first and second storey columns in shear, likely resulting in the observed gravity load failure [Sezen 2002 *et al.*].

Figure 8. Views from a collapsed apartment building in Golcuk: (a) view of front facade of building; (b) view of infill wall perpendicular to sidewalk

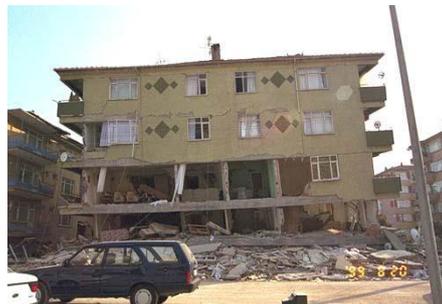
The first two storey of the building in Figure 9 collapsed. The masonry infill walls and moment-frame construction in the third and fourth storey (first and second storey in the photograph of the collapsed building) suffered major damage. Damage in this building reduced with increased height above the ground. Failure of the masonry infill in the first and second storey of the building likely precipitated the collapse of the building.

Figure 9. Failure of two stories of a reinforced concrete frame building with infill walls.

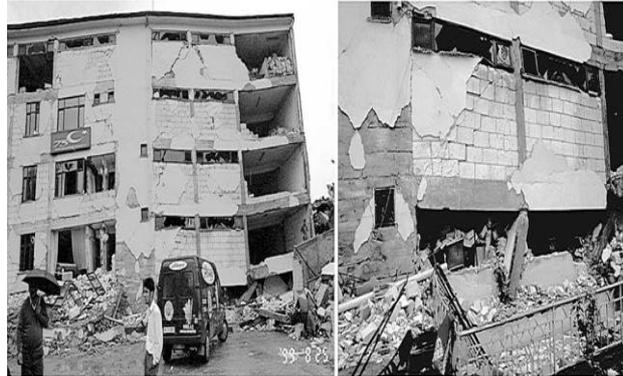
non-ductile framing system in the elastic range. The most significant damage observed by the team in a dual wall-frame building is shown in Figure 10. The wall and first-storey exterior columns shown failed and shortened. No cracks were observed in the shear wall, but the right end settled approximately 500 mm due to bearing failure of the supporting soils. Although the shear wall was likely sufficiently stiff to protect the non-ductile frame, the rotation at the base of the shear wall and the settlement of the footings beneath the moment-frame columns contributed to the failure of the first-storey columns.

Figure 10. Damage observed in a dual wall-frame building

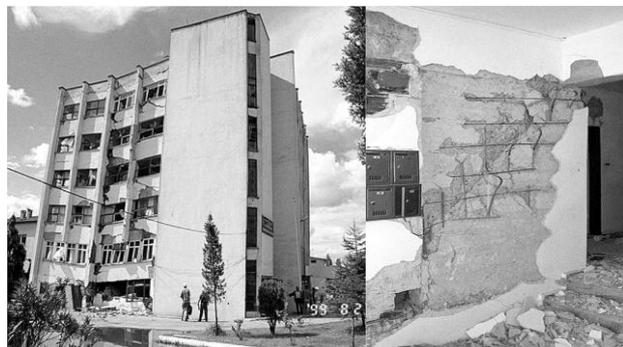
Blade columns or narrow shear walls were often constructed near stairwells (Fig. 11). These walls or blade columns were detailed similarly to regular moment frame columns with light transverse reinforcement with 90-degree hooks and no cross ties.

Figure 11. Damages in blade columns or narrow shear walls near stairwells

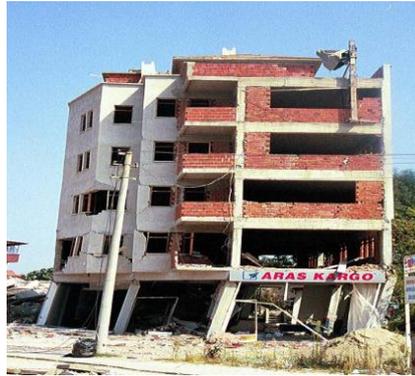
Irregular placement of masonry infill walls can produce discontinuities of stiffness in moment- frame buildings. Consider the building in Figure 12 in which the moment frame is both flexible and weak in the first storey by comparison with the upper storey. In the first storey of this building, masonry infill walls are present in the back face of the building and in the two faces perpendicular to the sidewalk. The front of the building was open in the first storey. The lateral stiffness of the building was considerably larger in the direction perpendicular to the sidewalk compared with parallel to the sidewalk. Deformations are concentrated in the first storey of this building parallel to the sidewalk, due to the weakness and flexibility of the moment frame because of lack of masonry infill walls in the front of the building. The first-storey columns in this building were severely damaged and likely close to failure due to gravity load instability [Sezen, 2002 *et al.*].

Figure 12. Soft first stories caused many residential and commercial buildings to collapse
