Durability of external thermal insulation composite systems in Istanbul Turkey

Ecem EDİS, Nil TÜRKERİ¹

Istanbul Technical University Faculty of Architecture, Istanbul TURKEY

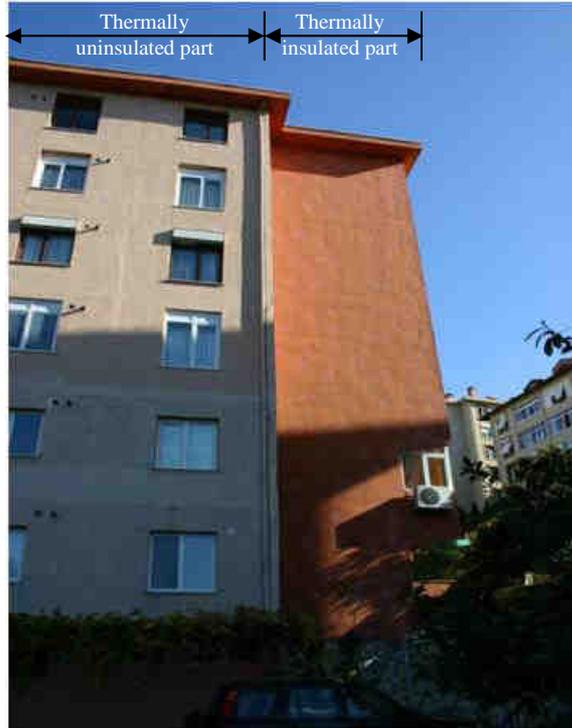
Even though the government issued policies to promote energy efficiency since 1985, correct design and proper installation of the system by the designers and contractors required some time. Partial application of external thermal insulation system at a building; only onto facade(s) where highest heat loss occurred, and omitting some components such as mechanical fasteners, rendering mesh required for proper installation were among the common examples seen during the initial periods of the system application as demonstrated in Figure 1. The building in Figure1 has been built in 1996 in Istanbul, Turkey, when the TS 825:1985 standard was in force, but there was no thermal insulation at the exterior walls. Subsequent to the implementation of the TS 825:1998, interestingly, only an extension of the facade has been insulated, and the remaining parts left thermally uninsulated. No defects were observed at the thermally insulated part of the facade during the inspection performed at winter 2008, but the shapes of the mechanical fasteners were clearly visible. As stated by the facility manager, mechanical fasteners have not been used at the initial installation and after some time, some of the thermal insulation boards have been detached from the substrate. These detached boards has been replaced with new boards and covered with new base and finish coats. Additionally, mechanical fasteners have been applied onto the new and existing finish coats and then the facade has been painted. Therefore, the shapes of the mechanical fasteners were visible during the inspection.

Figure 1. An example to the thermal insulation applications carried out during the initial periods of becoming a common practice – the left hand side of the facade is thermally uninsulated and the other part is insulated

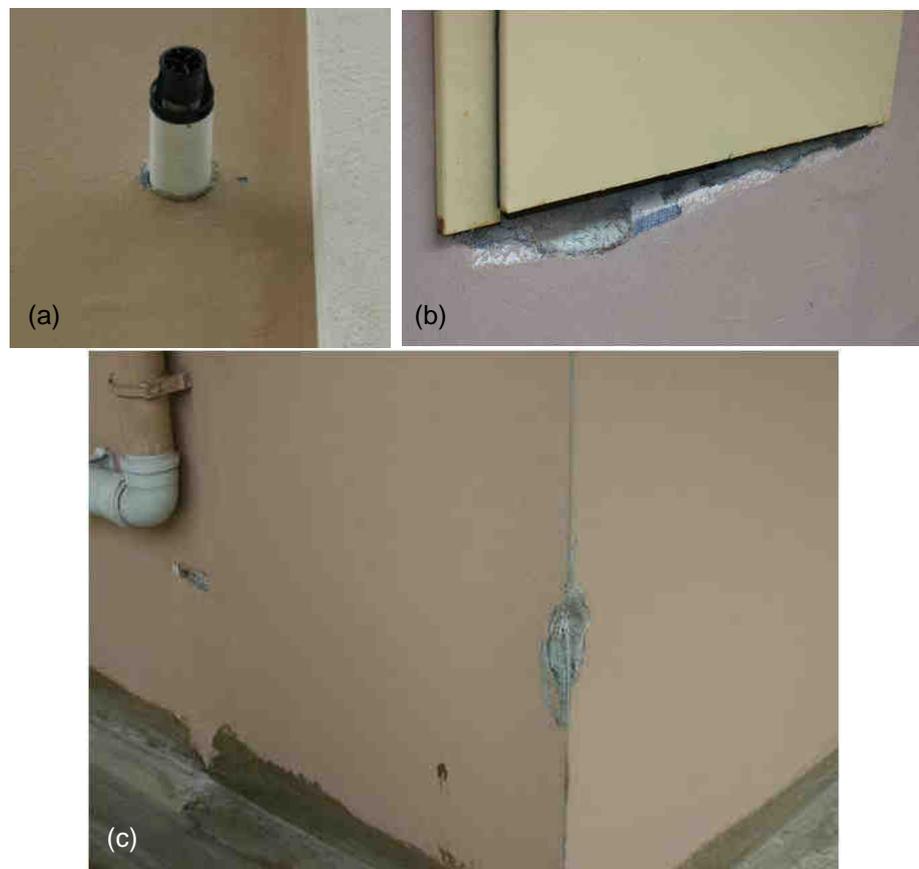
In building site A (BS-A), there are eight-storey high five residential buildings, which have been built in the year of 2007 and have been retrofitted with ETICS in the year of 2008. No defects originating from the external degradation agents were observed at all inspected facades of these buildings, hence all of these five buildings were classified as “virtually without defects” under assessment group 1. However defects resulted from internal degradation agents – i.e. assessment group 2 – were observed at most of the facades. In terms of these types of defects, Figures 3a and 3b demonstrate examples at a wall-pipe interface and a wall-closet interface,

respectively. A closer examination of the wall-pipe interface revealed the fiberglass mesh while whole components of the ETICS could be observed at the wall-closet interface. It is considered that the interfaces have been imperfectly designed and the penetrations have been defectively installed. Additionally, Figure 3c illustrates delamination due to impact loads at ETICS at the ground floor level of building at BS-A.

Figure 3. Examples of the defects observed at BS-A: (a) delamination at wall-pipe interface, (b) wear off at wall-closet interface, (c) delamination due to impact load.

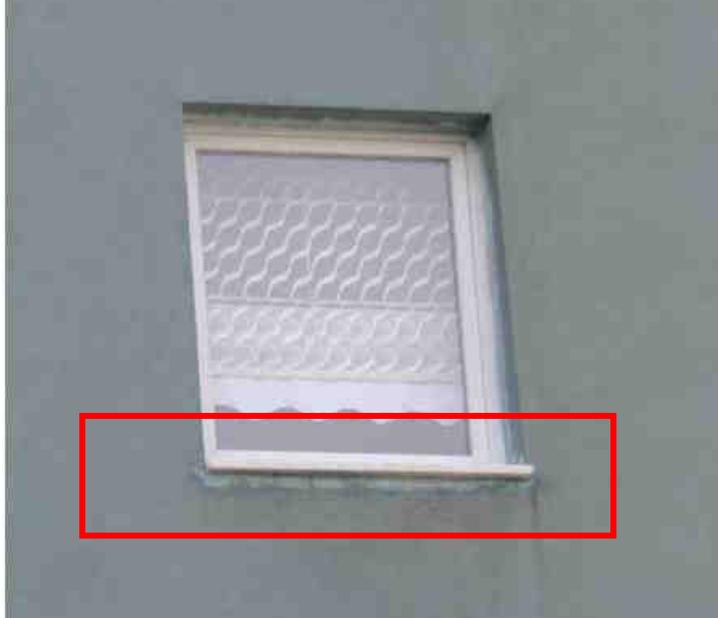
In BS-C, buildings have been constructed in the year of 1991; only one building has been thermally insulated with XPS based ETICS in the year of 2004 and no maintenance work has been carried out since the given date. No defects due to external degradation agents were observed during the inspections and hence, all the facades of the building were classified as 'virtually without defects'. However, it was observed that during the renewal of window frames and sills by the owner of the apartments, some parts of the thermal insulation boards have been left exposed to the environment due

to improper construction work (Figure 4), and hence the facades were classified as 'with defects' under the assessment group 2.

Figure 4. Exposure of thermal insulation material due to renewal of window frame and sill at BS-C

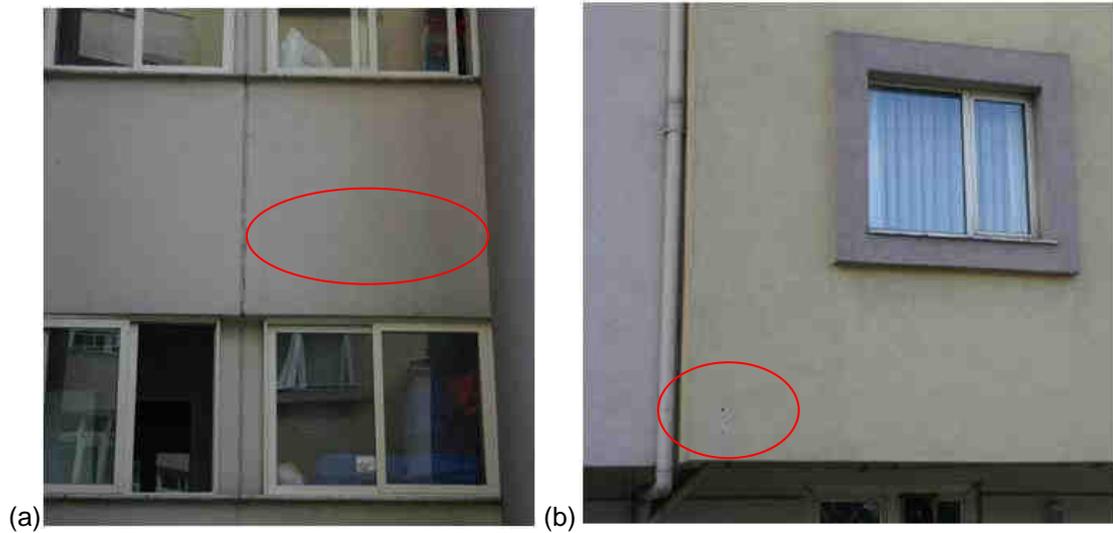
In BS-E, there are eight-storey high three buildings, which have been constructed in the year of 1999. ETICS have been installed in the year of 2003 and no maintenance has been carried out since then. During the inspection, only a single isolated defect due to external degradation agents, i.e. a crack at the interface of reinforced concrete beam and brick infill (Figure 5a), was observed at one facade and therefore all the facades were classified as 'virtually without defects'. On the other hand, use related defects such as drill holes that have not been repaired after the removal of mounted items like lighting fixtures, security cameras, etc. were observed at several facades (Figure 5b), and hence the facades were classified as 'with defects' under the assessment group 2.

Figure 5. Examples from BS-E: (a) crack at floor beam-infill wall interface, (b) drill hole that has not been repaired after the removal of a security camera

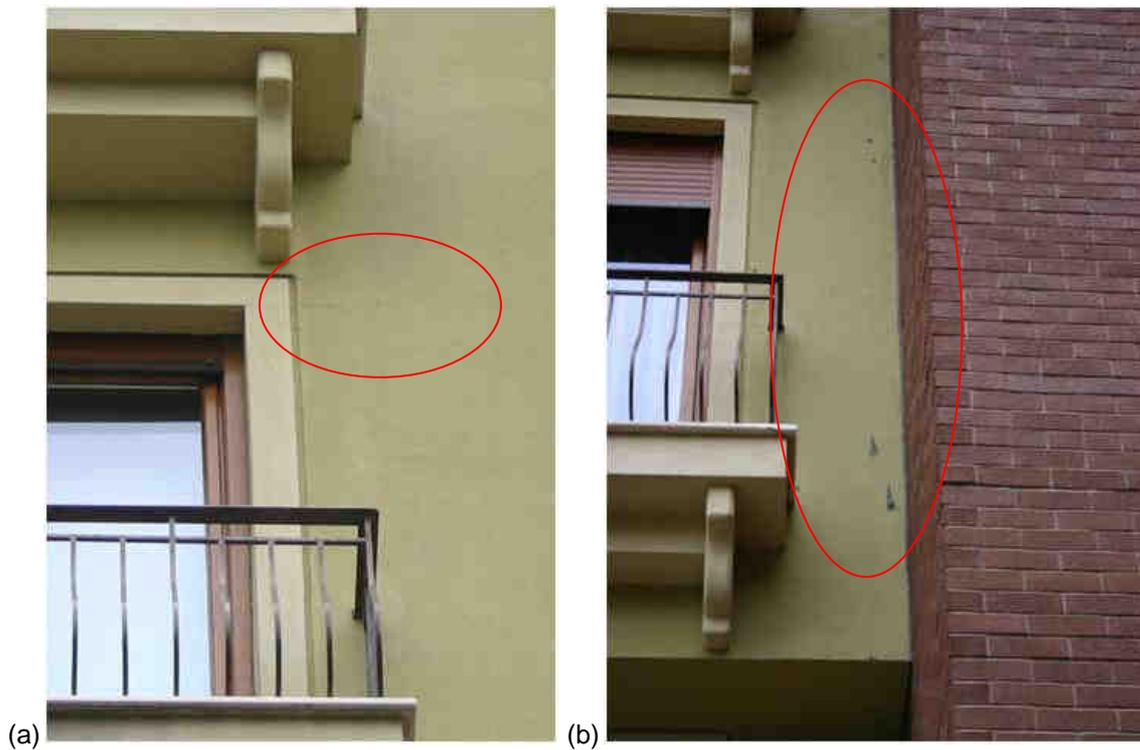
BS-F stationed 15-storey high two buildings, which have been constructed in the year of 2003 with ETICS. Apart from 1-2 isolated cracks at window corners (Figure 6a), there were no defects due to external agents and hence all facades were classified as 'virtually without defects'. In terms of internal degradation agents, delamination problems caused by the impact of falling tiles from the upper portion of the walls and during the replacement of the missing tiles, were observed as explained by the facility manager of the buildings, and therefore the facades were classified as 'with defects' (Figure 6b).

Figure 6. Examples from BS-F: (a) isolated crack at window corner, (b) delamination problems that have been occurred due to the impact of falling tiles

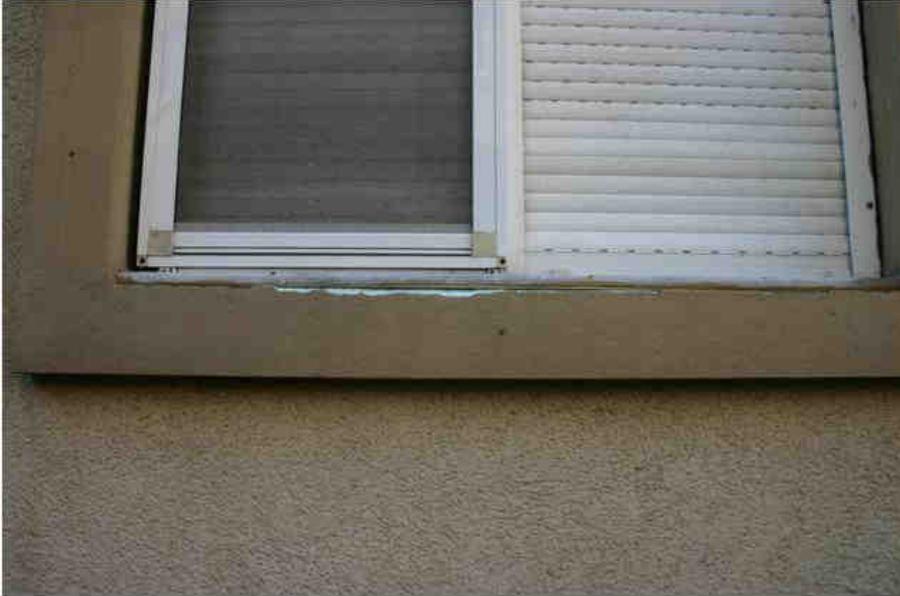
In BS-G, three buildings of five to six-storey high have been built in the year of 1991 and have been thermally insulated with XPS based ETICS in the year of 2001. No maintenance work has been carried out since the given date. No defects due to external environmental agents were observed during the inspection and all facades were classified as ‘virtually without defects’. In terms of internal degradation agents, several defects such as

delamination due to defectively installation of an air-conditioning unit, drill holes etc were observed. Figure 7 presents an example of these types of defects; i.e. wearing off the finish coat and exposure of thermal insulation material to the atmosphere at the window sill due to improper detailing and construction.

Figure 7. Exposure of thermal insulation material to the atmosphere due to wearing off the finish coat at BS-G

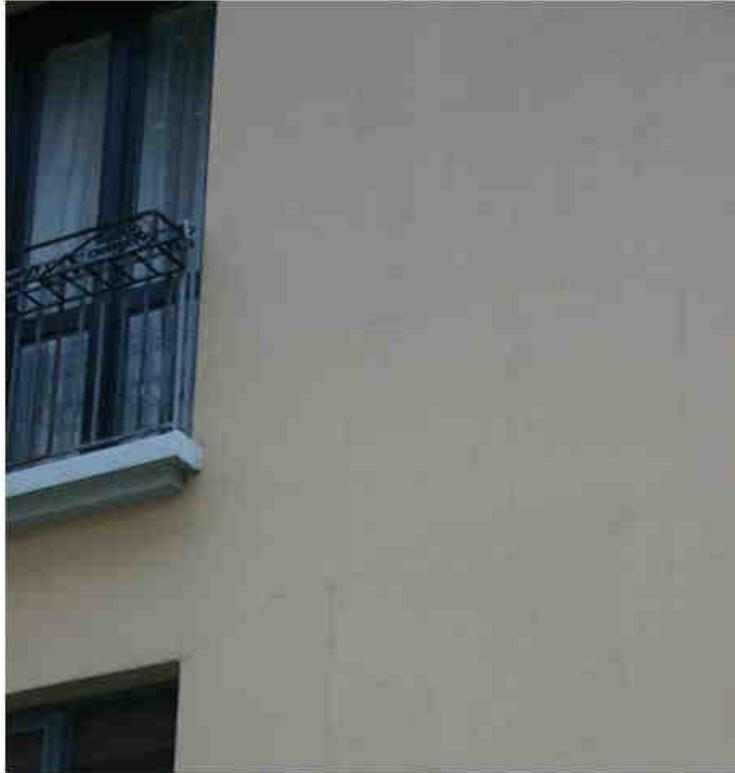
BS-I comprised five to six storey-high 23 buildings. XPS based ETICS have been installed during the initial construction and regular maintenance work has been carried out at every 4 to 5 years. During the inspection, longer groove cracks were observed at most of the facades of 23 buildings in terms of the effect of external degradation agents. Therefore the facades were classified as 'minor defects' under the assessment group 1. An example facade with this type of defect is provided in Figure 8. In terms of internal degradation agents, 23 buildings were observed to be defect free.

Figure 8. Example to the cracks observed in most buildings at BS-I
