Workshop Study on Impact of 2011 Van Earthquake on Rural Settlement Houses

Ali Rıza PARSA

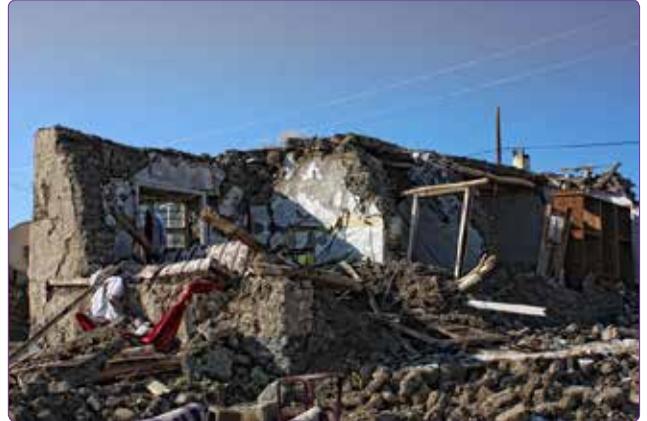
Adobe structures have been used for centuries all around the world as they are easy to construct and provides energy saving and a healthy life. Nevertheless, as a result of the fact that the soil used in the adobe structures in the pilot region is not appropriate for adobe structures and that no additives are included in the soil, the adobe structures were damaged by the earthquake. The correct choice of adobe soil ensures a durable adobe block. Furthermore, adobe is extremely durable against water. Additive agents are required for ensuring that adobe structures are affected less by water. “Generally speaking, gravelly soil is not appropriate for adobe constructions. The most appropriate types of soils for adobe constructions are sandy clay and or clayey sand.

The addition of cement or lime, or both if possible, to adobe grout to prevent dissolution when it gets wet or cracking and disintegration when it dries is crucial. As a result of several experiments carried out, it was found out that an addition of 5% cement or 10% lime to adobe grout to ensure soundness and to prevent disintegration when it gets wet, cracking when it dries and freezing”⁵ (Figure 3).

Figure 3. An adobe structure damaged by earthquake as a result of inappropriate material choice (Parsa, A.R. Archive, 2011).

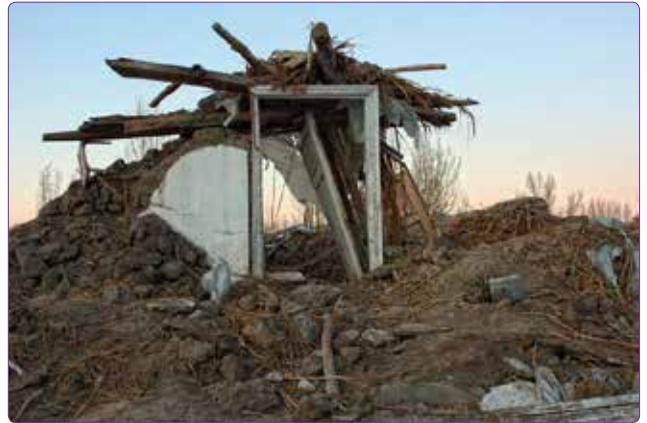
Some of the masonry structure with stone walls in the pilot region, as a result of the use of undressed stone and the low quality mortar, were damaged by earthquake (Figure 4).

Figure 4. A structure with stone walls, broken down as a result of use of undressed stone and low quality mortar (Parsa, A.R. Archive, 2011).

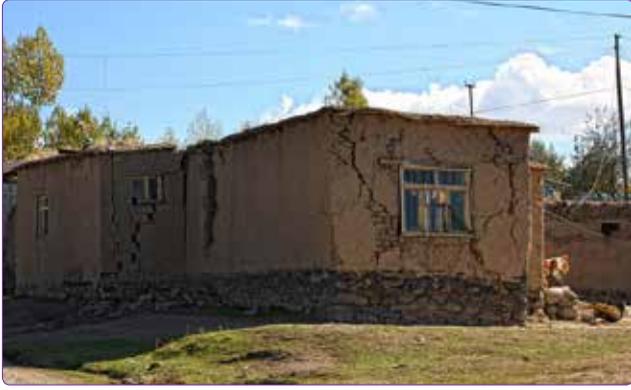
A part of the houses in the pilot region was damaged during the earthquake as they were not formed suitable for earthquake zones. Figure 6 shows a damaged structure with a form in the shape of T.

Figure 6. T-Planned structure damaged during the earthquake (Parsa, A.R. Archive, 2011).

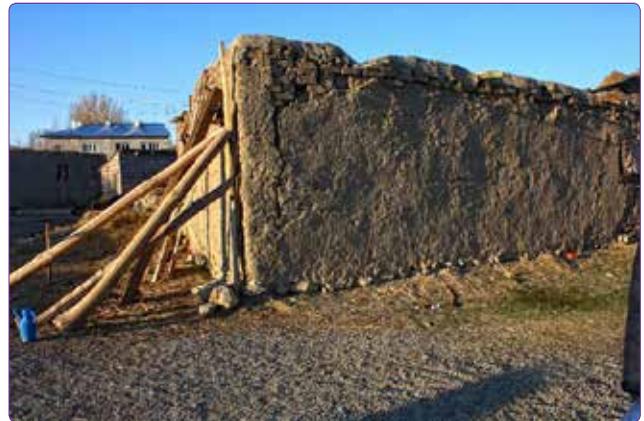
As shown in Figure 8, supporting the structure damaged in 2011 Van earthquake temporarily with wooden props proves how important Adeli's and Author's suggestions were years ago.

Figure 8. Building which was supported by props after 2011 Van Earthquake (Parsa, A.R. Archive, 2011).

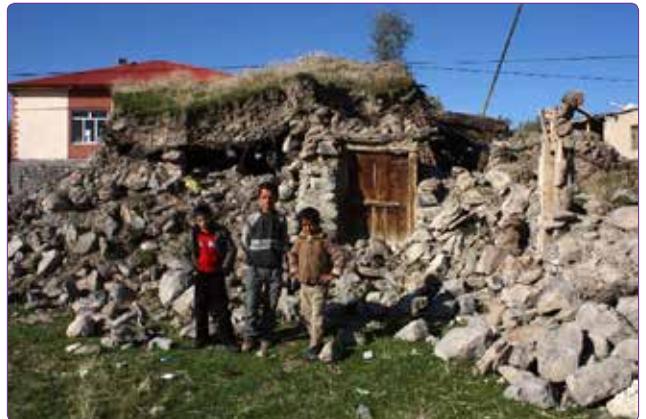
Mud coated heavy ceiling coverings are built on walls independent of the walls. Heavy tiles on the one hand and their operation during earthquake independent of walls on the other hand emerge as important damage causes. “The ceilings of rural structures with mud-brick and stone walls are generally covered with mud. One meter square weight of the wooden bearer and mud covering of the ceiling is about 750-1000 kg. Therefore a huge ceiling load presses on the walls. The walls are already under difficult conditions during an earthquake due to their construction, so it is inevitable that they will be damaged during earthquake because of heavy ceiling”.⁷ Figure 10 shows a heavily damaged building with mud ceiling in the pilot region.

Figure 10. A heavily damaged building with mud ceiling (Parsa, A.R. Archive, 2011).

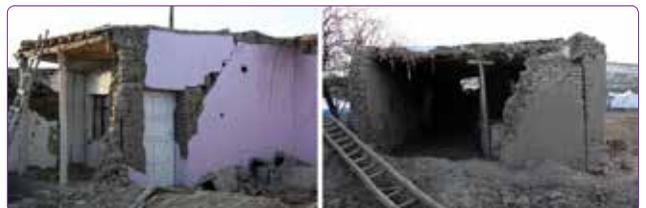
Figure 11 presents earthquake-damaged houses in the pilot region. As can be seen in the figure, a lot of incorrect structural details emerged in the buildings. The fact that the parts annexed to the structure depending on the increase of population within the family are not built in accordance with earthquake load is yet another significant cause of damage.

The damages in Figure 11 indicate that the villagers have also been moving away gradually from the construction culture that has formed for ages.

Figure 11. Damaged buildings in the pilot region (Parsa, A.R. Archive, 2011).

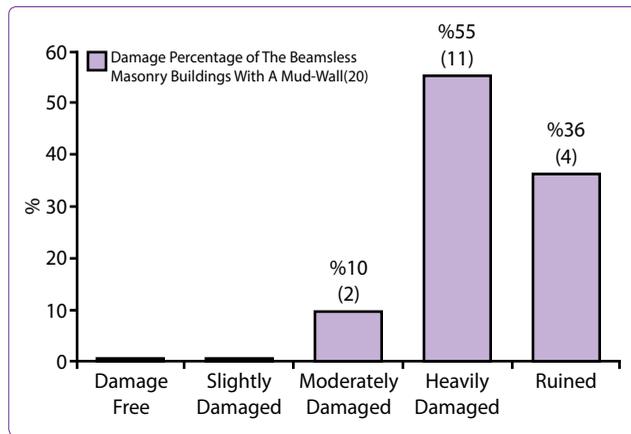
During the research carried out, it was found out that beams were not used in the majority of the houses. Figure 12 gives information about damage percentage of the beamless masonry buildings with mud-wall and Figure 13 presents the damage percentage of the masonry buildings with stone walls and beams.

As understood from Figure 12 and 13, the damage level between buildings with beams and those built beamless is significantly different. Figure 13 indicates that the use of horizontal beams as structural detail affects the behaviors of the structures against

Figure 12. Damage percentage of the beamless masonry buildings with mud-walls (Prepared by Author, 2012).

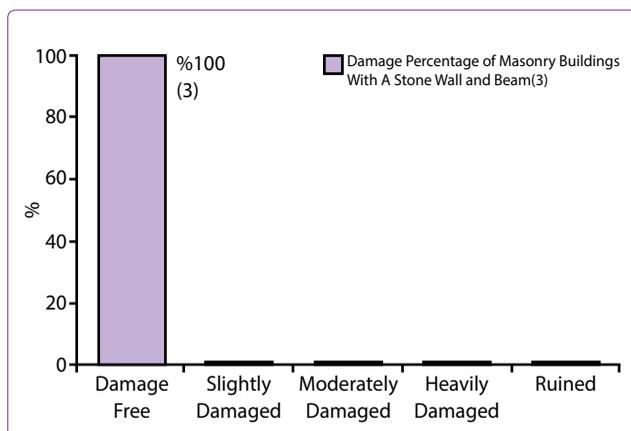
Figure 13. Damage percentage of the masonry buildings with stone walls and beams (Prepared by Author, 2012).
