A rare complication of aortic valve replacement surgery- aorta-right ventricular fistula: an evaluation with real-time multiplane echocardiography

Serkan Çay, Omaç Tüfekçioğlu, Sezgin Öztürk

Department of Cardiology, Türkiye Yüksek İhtisas Heart-Education and Research Hospital, Ankara, Turkey

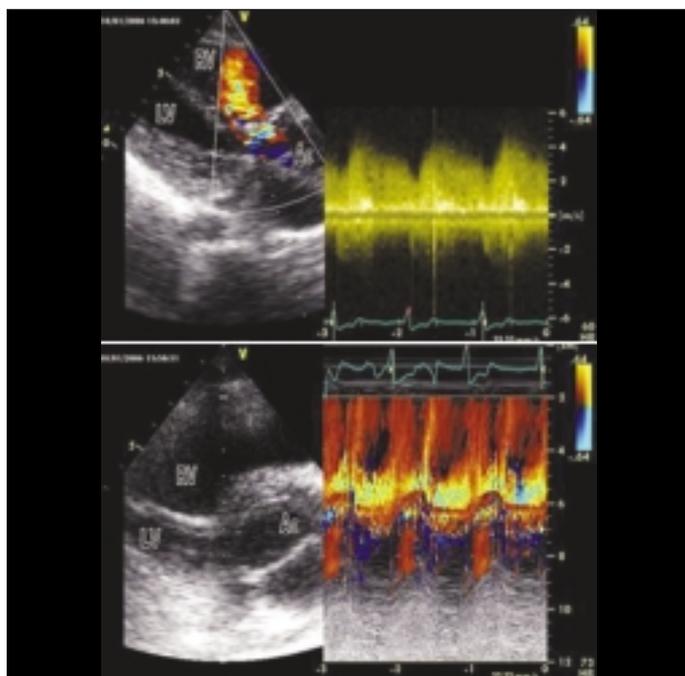
Figure 1. Transthoracic echocardiography with continuous-wave Doppler (top) and color M-mode (bottom) images showing continuous flow pattern in parasternal long-axis view

jet entering the right ventricle from the aortic root through a fistula formation was detected by color Doppler imaging. After that, heart was evaluated by real-time multiplane (tri-plane) color Doppler echocardiography and the high-velocity jet was demonstrated through 3 different tomographic image planes (GE Medical Systems, Vivid 7 Dimension, Horten, Norway) (Video 1. See corresponding video/movie images at www.anakarder.com). In addition, continuous flow pattern was observed by continuous-

wave Doppler and color M-mode echocardiography (Fig. 1). Aortic root angiography revealed a passage between the aorta and the right ventricle (Fig. 2). Although complications such as infection, valve dehiscence, and mechanical dysfunction might be seen with the prosthetic valves; fistula formation between the aorta and the other cardiac chambers is very rare. Some of such fistulous connections might be overlooked if a careful examination is not performed.

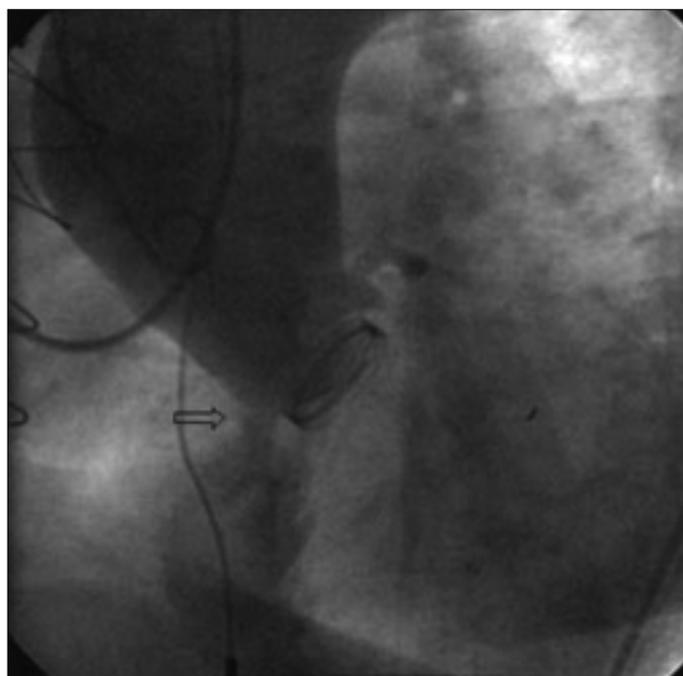
Figure 2. Aortography demonstrating a fistulous connection between aortic root and the right ventricle just above the mechanical prosthesis (arrow)
