An Unusual Cause of Electrocardiographic Artefact: A Patient's Warming Blanket

Sanjay Gandhi Post Graduate Institute of Medical Sciences, Lucknow, India

Cite this article as: Misra G, Dhiraj S, Kapoor A, Goyal P. An Unusual Cause of Electrocardiographic Artefact: A Patient's Warming Blanket. Turk J Anaesthesiol Reanim 2018; 46: 161-3.

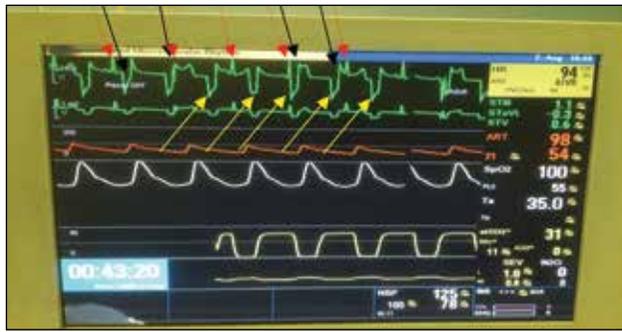
1. Clear presence of normal sinus rhythm, with narrow QRS complexes in both monitor strips (marked by red arrows in Figure 1).

Figure 1. Monitor showing electrocardiographic artefacts

2. The ventricular myocardium has a refractory period (approximately 250 ms) wherein after an action potential, the tissue remains refractory for any ensuing cardiac impulse. Thus before or after sinus beat (marked by red arrows), it would be physiologically impossible for the myocardium to be rapidly depolarised to produce a second QRS complex (marked by black arrows).

3. The QRS complexes marked by yellow arrows were confirmed to be artefacts because they appeared in too rapid succession following or preceding a normal sinus complex, which would be physiologically impossible with a normal AV conduction (Figure 1).

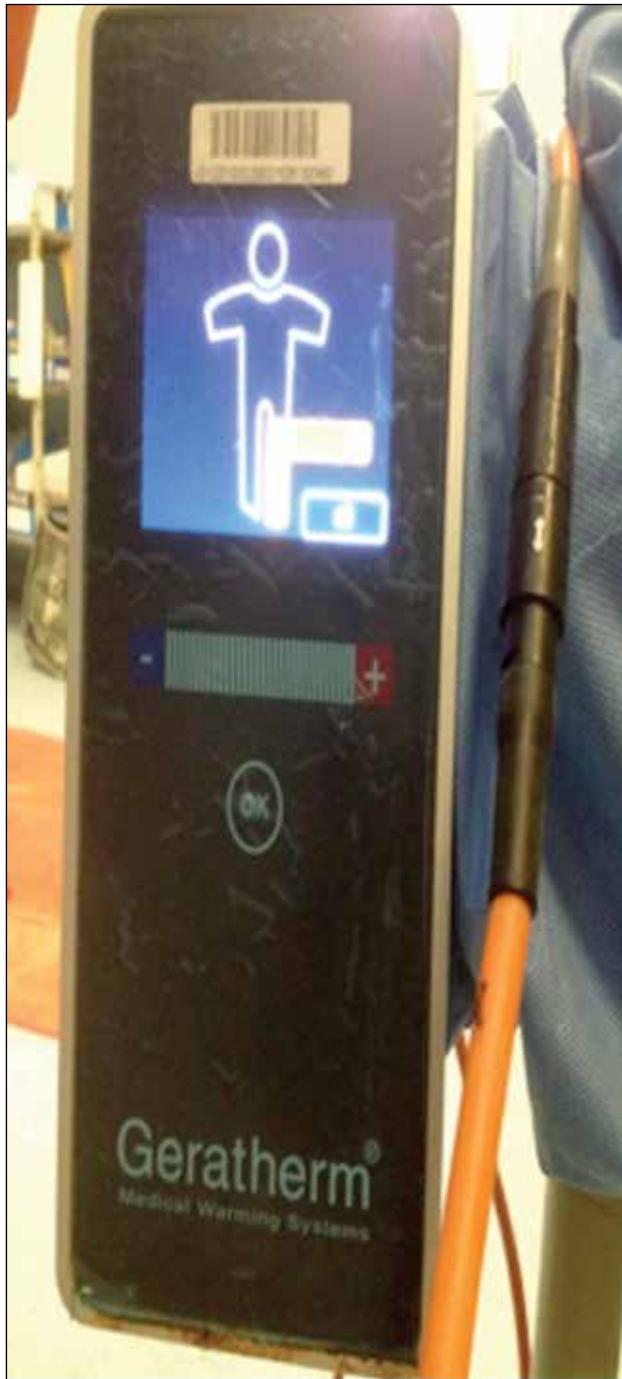
Figure 2. Patient's warming apparatus (Geratherm®)

During this intensive search for the cause of ECG changes, when the patient's warmer (Geratherm®) (Figure 2) was turned off, the ECG reverted back to sinus rhythm, concluding that the warmer was causing the artefacts.

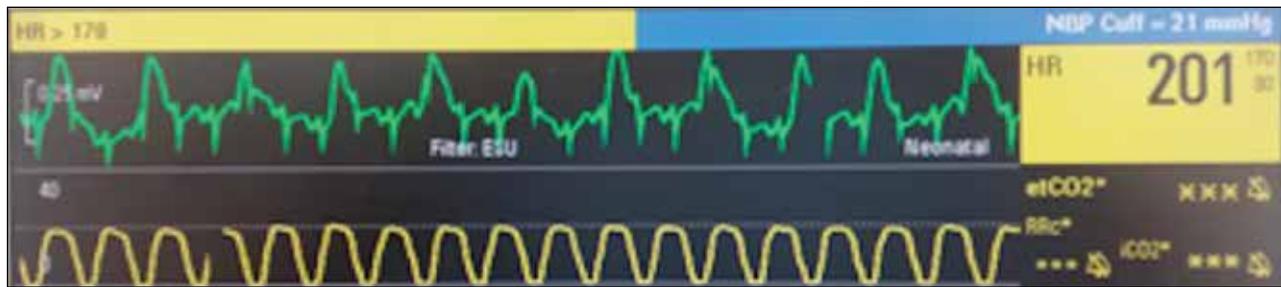
We encountered a similar incidence of ECG artefacts in a 7-year-old boy who was to undergo laparotomy under general anaesthesia. ECG artefacts were similar to those described above (Figure 3). We immediately diagnosed that the artefacts occurred because of the warmer, and after switching off the warmer, ECG returned to sinus rhythm (Figure 4).

Figure 3. Monitor showing electrocardiographic artefacts

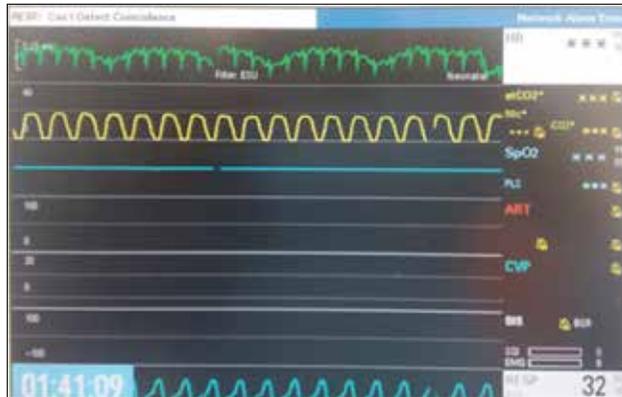
Figure 4. Monitor displaying normal sinus rhythm after switching off the warmer
