Reduced biventricular pacing: What is the mechanism and how to manage it?***Azalmış biventriküler pacing: Mekanizma nedir ve nasıl yaklaşalım?***

● Enes Gul, M.D.,¹ ● Sohaib Haseeb, M.D.,² ● Mohammad Melhem, M.D.,¹
● Osama Al Amoudi, M.D.,¹ ● Adrian Baranchuk, M.D.²

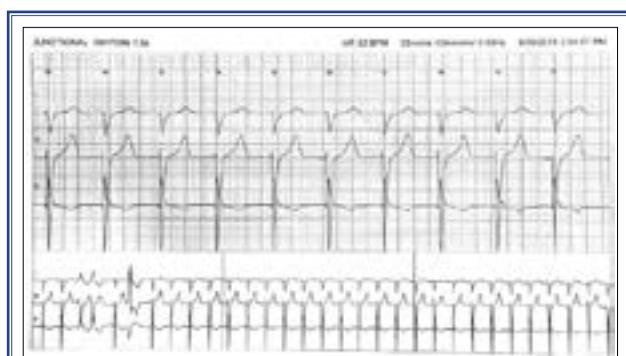
A 24-hour Holter cardiac monitor device was requested to assess the correlation between the rhythm tracings and device diagnostics, and to determine the morphology and burden of possible PVCs. The Holter monitor report indicated that there were occasional PVCs with frequent episodes of non-paced ventricular rhythms

without preceding atrial activity (Fig. 2). The following reasons and potential solutions for re-

Figure 2. A 24-hour Holter recording showing accelerated junctional rhythm at 80 bpm with retrograde P-waves.

promote the intrinsic rhythm. This was confirmed with Holter monitoring (Fig. 2) and with the intracardiac electrograms stored in the device (Fig. 3). Both tracings depicted simultaneous ventricular and atrial activities and supported the diagnosis of an accelerated junctional rhythm at 80 bpm. In this case, we added a beta-blocker (Bisoprolol 5 mg once daily by mouth) in order to suppress AV node automaticity. One month after beta-blocker initiation, follow-up biventricular pacing had increased to 88%. Other possible solutions could be to increase the lower rate or catheter ablation in case of failure to respond to medication.

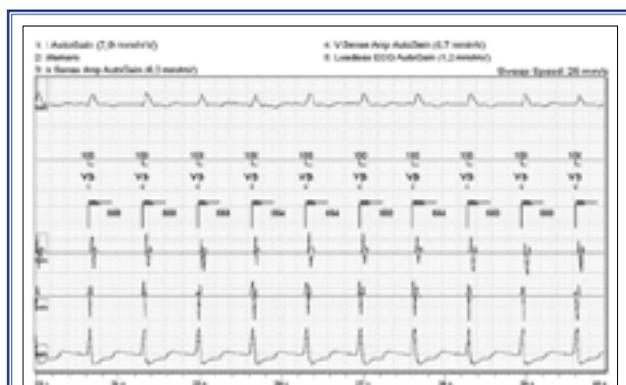
Figure 3. Device recording depicting simultaneous atrial and ventricular electrograms and atrial activities falling in the post ventricular blanking period. Note that there is no visible atrial activity (P-wave) in the electrocardiogram channel.
