An assessment on traditional timber structures in Süleymaniye and Zeyrek districts of Historical Peninsula

This study was made on the wooden structural and decorative elements of the 19th century traditional timber buildings in Süleymaniye and Zeyrek Districts, to analyze the structural deteriorations and to identify the woods used.

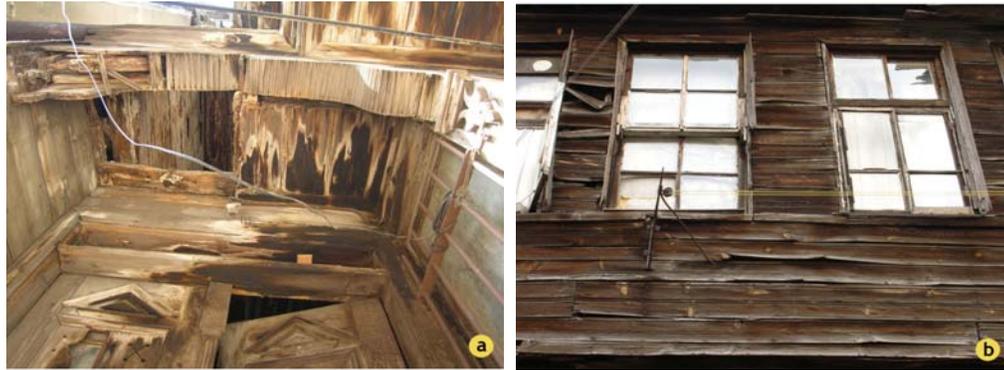
Figure 3. Physical deteriorations. a- Deterioration by humidity effects at the ceiling of a timber house in Süleymaniye. b- Deterioration by atmospheric effects on facade of a timber house in Zeyrek.

The observation results can be seen from Table 1 and also from Figures 3-6. The photographs present observations and examples showing the mechanical condition of some existing buildings which have been damaged over time.

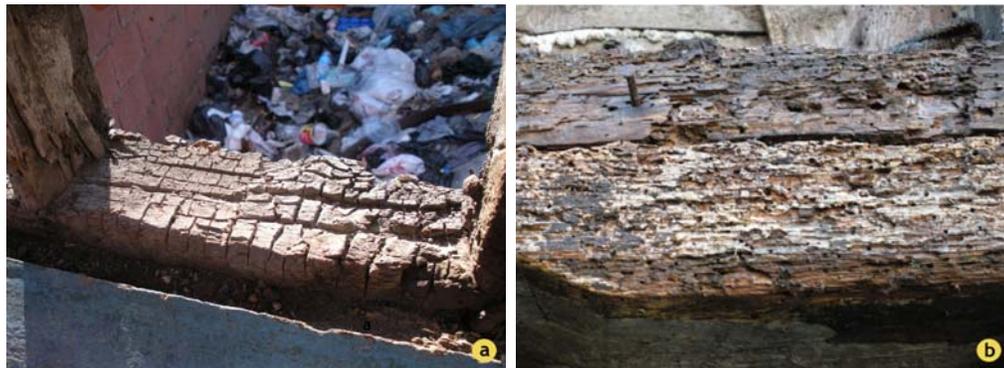
Figure 5. Biological deteriorations. a- Timber damaged by wood-destroying fungi. Brown rot fungi are the most destructors of historic timber buildings (Kisternaya and Kozlov, 2009). At the final stages of the attack, wood grows brown in color and breaks apart into cube-shaped pieces. b- Timber damaged by wood-destroying insects. Important pests of timber in historical buildings in this region are beetles belong to the family Anobiidae.

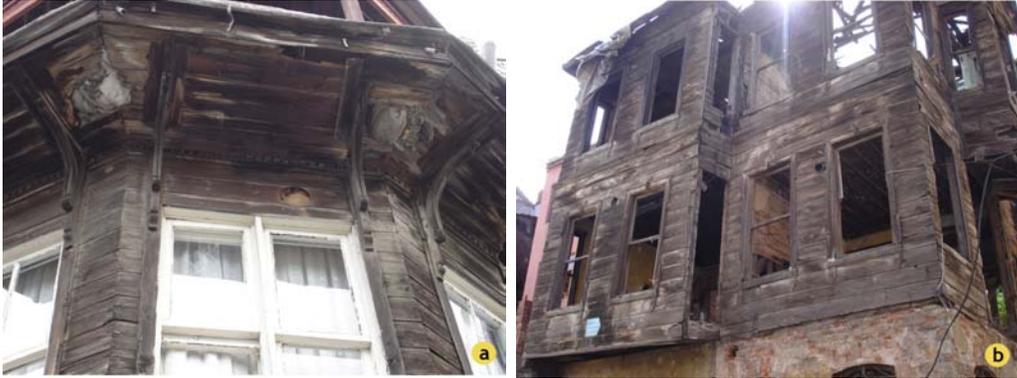
Figure 6. Human-sourced deteriorations. a- Incorrect attempts at restoration, a house in Zeyrek. b- A house that was abandoned to its fate in Süleymaniye.
