## CASE REPORT

## The other side of the coin in primary tricuspid valve disease: The incremental value of 3D echocardiography

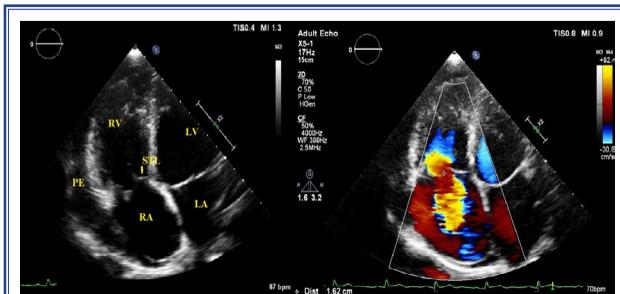
**Figure 1.** Transthoracic apical 4-chamber view without and with color Doppler showed posterior tricuspid valve leaflet prolapse and a normal septal leaflet. The right side revealed severe tricuspid regurgitation on color Doppler examination (Vena contracta width: 1.02 cm; proximal isovelocity surface area radius: 1.62 cm). LA: Left atrium; LV: Left ventricle; PE: Pericardial effusion; RA: Right atrium; RV: Right ventricle.

trocardiogram indicated a sinus rhythm of 75/bpm. Transthoracic echocardiography (TTE) revealed prolapse of the posterior tricuspid valve leaflet with redundant tissue, severe TR (vena contracta, 1.02 cm), mild pericardial effusion, and normal left ventricle and mitral valve function (Fig. 1). Posterior tricuspid leaflet prolapse and chordae tendineae rupture were clearly observed with a 3-dimensional (3D), 4-beat, full volume examination using TTE with a Philips X5-1 ultrasound transducer probe (Philips Health-

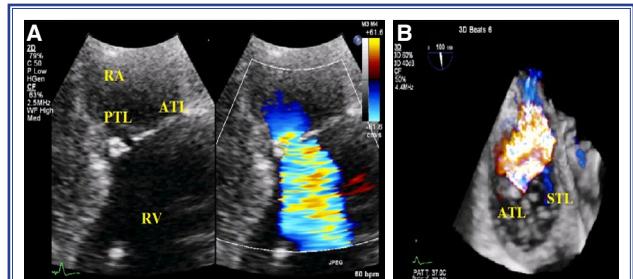
**Figure 3.** (A) From the transthoracic parasternal long-axis right ventricle inflow view, the anterior tricuspid leaflet appeared normal, but septal or posterior leaflet tissue loss was causing severe tricuspid regurgitation. (B) Transesophageal 3-dimensional color flow examination showed severe tricuspid regurgitation from posterior leaflet tissue deformation that likely occurred during removal of a pacemaker. ATL: Anterior tricuspid leaflet; PTL: Posterior tricuspid leaflet; RA: Right atrium; RV: Right ventricle; STL: Septal tricuspid leaflet.

performed due to infective endocarditis, and an epicardial VVI pacemaker had been surgically inserted. The 2D mid-esophageal 4-chamber view and 3D 1-beat zoom mode (Fig. 4), along with 3D color Doppler examination (Fig. 3b) showed severe TR, probably due to posterior leaflet tissue loss during removal of the pacemaker. Surgery to repair the tricuspid valve was recommended, but the patient declined. He has been followed up with medical treatment for continued NYHA class II dyspnea for 1 year.
