Degenerated bioprosthetic mitral valve thrombosis as a rare cause of cardiac source of thromboembolism

Department of Cardiology,
Kosuyolu Kartal Heart Training
and Research Hospital, Istanbul

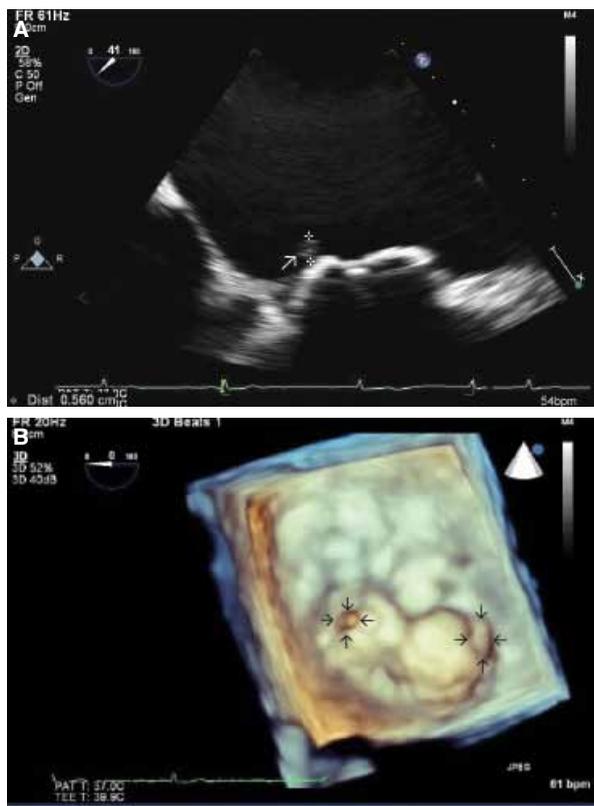
Figures— Two-dimensional transesophageal echocardiography (TEE) showed 5 mm mobile thrombus attached on the atrial side of the degenerated bioprosthetic mitral valve (A) and real-time three-dimensional (3D) TEE confirmed the mobile thrombi on the left atrial side of the bioprosthetic valve (B). (C) Macroscopic appearance of the two mobile thrombi (arrows) located on the left atrial side of the degenerated mitral bioprosthetic valve during surgery. *Supplementary video files associated with this presentation can be found in the online version of the journal.

in the left eye for five minutes. The bioprosthetic valve had been preferred as the patient had desired pregnancy. On admission, her neurological and retinal fundus examinations were normal as well as cranial computed tomography. She had been complaining of progressive dyspnea for the past five years. Transthoracic echocardiography showed normal left ventricular systolic functions. Subsequently, two-dimensional (2D) transesophageal echocardiography (TEE) revealed increased transvalvular gradients (25/12 mmHg) with decreased valve area (1.1 cm²). Two mobile thrombi (5 mm and 3 mm) were detected on the left atrial side

of the leaflets (Fig. A, Video 1*). Real-time (RT) three-dimensional (3D) TEE confirmed the presence of mobile thrombi on the left atrial side of the bioprosthetic valve (Fig. B, Video 2*). Doppler ultrasound revealed normal blood flow in carotid and vertebral arteries, which led us to consider that the thrombi on the bioprosthetic valve was likely to be the source of thromboembolism and transient ischemic attack. The patient underwent redo valve surgery, and the degenerated bioprosthetic valve was replaced with a mechanical valve (29 mm Carbomedics). The thrombi were observed on the atrial side of the valve during surgery (Fig. C), and pathological examination confirmed the diagnosis of thrombosis. Unlike mechanical prosthetic valves, bioprosthetic valves are associated with a very low rate of thrombosis. Thromboembolic complications may be associated with bioprosthetic valve thrombosis. RT-3D TEE permits detailed structural assessment of prosthetic valves and therefore has advantages over 2D TEE in terms of depiction of prosthetic valve thrombosis.
