An unusual pacing artifact

● Amjad Abualsuod, M.D., ● Hakan Paydak, M.D., ● Naga Venkata Pothineni, M.D.

Division of Cardiovascular Medicine, Department of Internal Medicine, University of Arkansas for Medical Sciences, Little Rock, Arkansas, USA

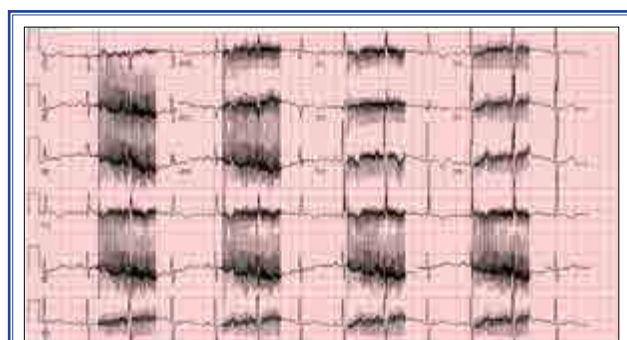
Figure 1. A 12-lead electrocardiogram recorded upon presentation revealing a cyclical artifact pattern.

clinic for a routine follow-up examination. A dual-chamber pacemaker had been implanted 12 years prior for sinus node dysfunction. The results of an initial 12-lead electrocardiogram (ECG) recorded on arrival are shown in Fig. 1. The observation of a cyclical pattern of multiple, rapid pacing stimulus artifacts prompted concern. An ECG recorded a year earlier had revealed a normal sinus

rhythm and biatrial enlargement. Device interrogation in the clinic revealed normal overall pacemaker function (normal sensing, thresholds, and lead impedance). Turning the pace gain function on the ECG machine off failed to eliminate the artifact. A review of past medical history revealed a diagnosis of congenital central hypoventilation syndrome and pulmonary hypertension, for which she underwent insertion of a diaphragmatic pacemaker (Avery Biomedical Devices, Inc., Commack, NY, USA). Interrogation of the diaphragmatic pacemaker revealed programmed parameters of a pulse interval of 50 milliseconds, inspiratory time of 1.2 seconds, respiratory rate of 27 per minute, and an output of 25 pulses per inspiration, which correlated with the frequency of the artifact noted on the ECG.

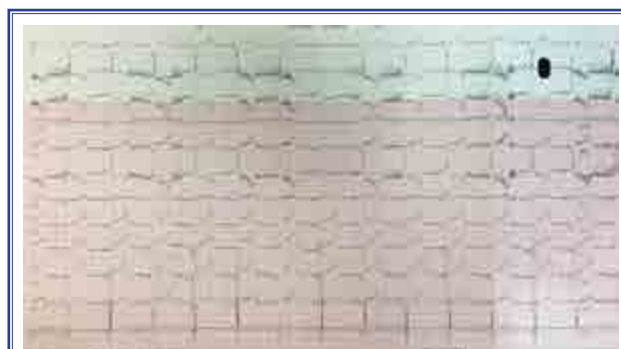
Figure 3. A 12-lead rhythm strip recorded during device interrogation demonstrating the cyclical pattern of diaphragmatic pacing as well as unaffected sequential atrioventricular (AV) pacing. The cardiac pacemaker was temporarily programmed to DDD 70 bpm, with a paced AV delay of 120 ms.

Interaction between the 2 systems is possible, although fortunately, it was not observed in the present patient (Fig. 3). Measures to minimize such interference include using bipolar rather than unipolar sensing parameters and adjusting the sensitivity to minimize far-field oversensing while maintaining an adequate safety margin. In extreme situations, lead repositioning may be required if these measures do not help. In addition, pacing the diaphragm at maximum output during cardiac pacemaker implantation or lead repositioning may help to assess for potential interference and determine the choice of pacing sites.
