## Very long-term durability of Hancock II porcine bioprosthesis on mitral position evaluation with real-time three-dimensional transesophageal echocardiography

Cüneyt Toprak  
Mehmet Özkan#  
Macit Kalçık  
Sinan Cerşit  
Mehmet Altuğ Tuncer\*

Department of Cardiology,  
Koşuyolu Kartal Heart Training and  
Research Hospital, Istanbul;  
#Department of Cardiology, Kafkas  
University Faculty of Medicine, Kars;  
\*Department of Cardiovascular  
Surgery, Koşuyolu Kartal Heart  
Training and Research Hospital,  
Istanbul

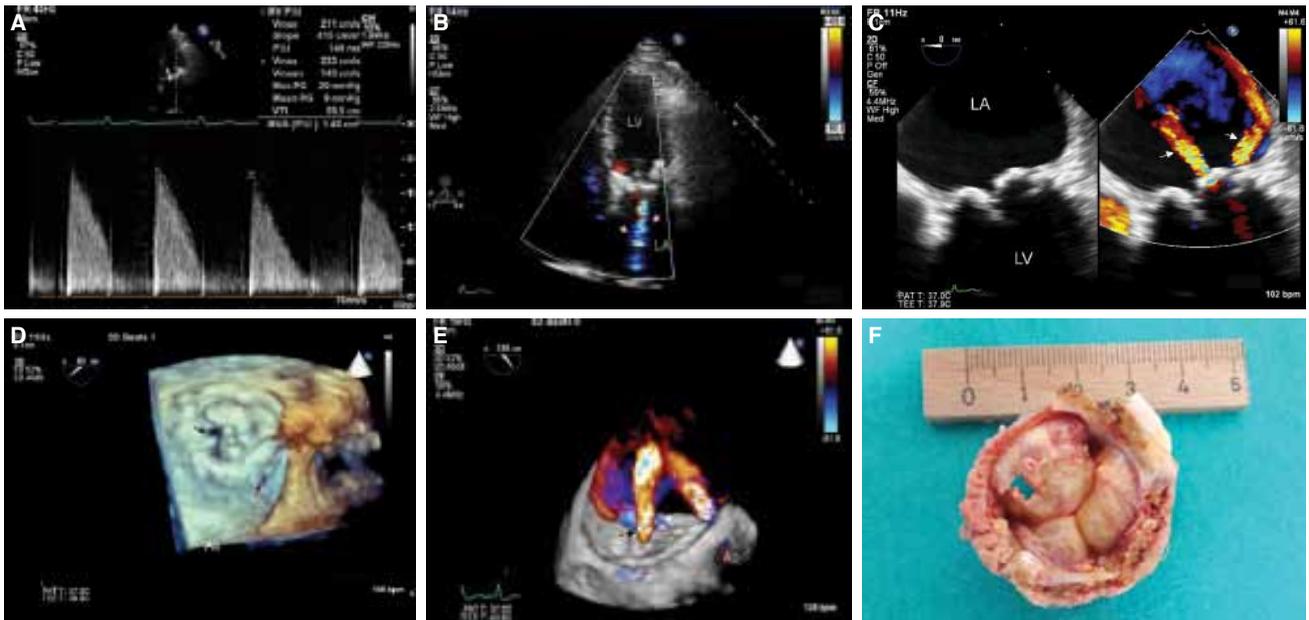
**Figures**– Transthoracic echocardiography showing moderate mitral stenosis (mitral valve area = 1.48 cm<sup>2</sup>, mean gradient = 9 mmHg) (A) and moderate mitral regurgitation jet (arrow) (B). (C) Two-dimensional transesophageal echocardiography and color image at 0° illustrating calcification of the leaflets and two mitral regurgitation jets (arrow). Three-dimensional transesophageal echocardiography showing mitral bioprosthesis from the left atrial aspect: a perforation is identified on the lateral side (black arrow), with additional paravalvular defect (red arrow) (D) Color image illustrating three severe mitral regurgitation jets; the first jet is from the paravalvular defect (red arrow), and the other jets are transvalvular (E). (F) Macroscopic examination of the bioprosthesis showing a perforation (Ao: Aorta; LAA: Left atrial appendage; LA: Left atrium; LV: Left ventricle).

A 57-year-old male, who had undergone mitral valve replacement with a 29-mm Hancock II bioprosthesis for mitral stenosis in 1987, was admitted to the outpatient clinic with exertional dyspnea. Transthoracic echocardiography revealed moderate mitral stenosis and regurgitation (Fig. A, B). Transesophageal echocardiography showed moderate calcification on the leaflets and two regurgitation jets (Fig. C). Real-time three-dimensional transesophageal echocardiography showed a perforation with additional paravalvular defect (Fig. D), and color image illustrated three mitral regurgitation jets (Fig. E). He was referred for valve surgery, the mitral bioprosthesis was removed, a no. 27 ATS mechanical prosthesis was replaced, and a no. 32 Contour 3D® annuloplasty ring was implanted to the tricuspid valve. Macroscopic examination revealed a perforation on the one of the leaflets (Fig. F). The case presented here is an extremely rare example of the long-term durability, over 26 years, of a Hancock II bioprosthesis in the mitral position. When a literature search was conducted, this case was found to represent the longest durability interval reported from the implantation of a bioprosthesis valve in the mitral position.
