CASE IMAGE

Multimodality imaging in a patient with lead perforation

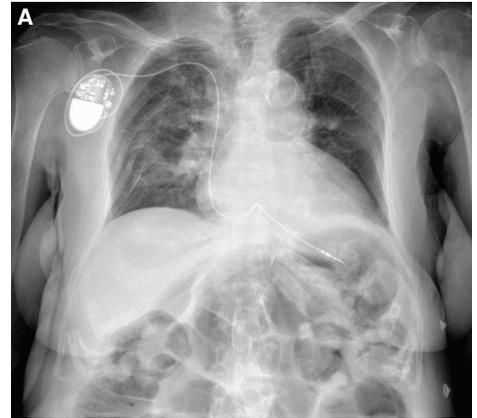
Figures– (A) Anteroposterior and (B) lateral chest X-rays revealing distal end of the lead below the right ventricle; (C) Two-dimensional transthoracic echocardiographic image in modified parasternal long axis view illustrates ventricular lead perforating the RV apex. *Pericardial space; RV: Right ventricle. (D) Multi-slice computed tomography image of distal end of the ventricular lead (yellow arrow) perforating the RV apex. *Supplementary video files associated with this presentation can be found in the online version of the journal.

The present case illustrates the complementary role of different imaging modalities in the assessment of permanent pacemaker lead perforation. A 92-year-old woman had undergone VVIR pacemaker implantation with active fixation via right subclavian vein at another hospital due to several syncopal attacks associated with atrial fibrillation and complete atrioventricular conduction block. Fifteen days after implantation, chest X-ray was performed at another hospital because of productive cough and suspicion of pneumonia. Image disclosed penetration of ventricular pacing lead through the right ventricle (RV) and reaching the left hemidiaphragm (Figure A, B). The patient was referred
