Workshop Study on Impact of 2011 Van Earthquake on Rural Settlement Houses

Ali Rıza PARSA

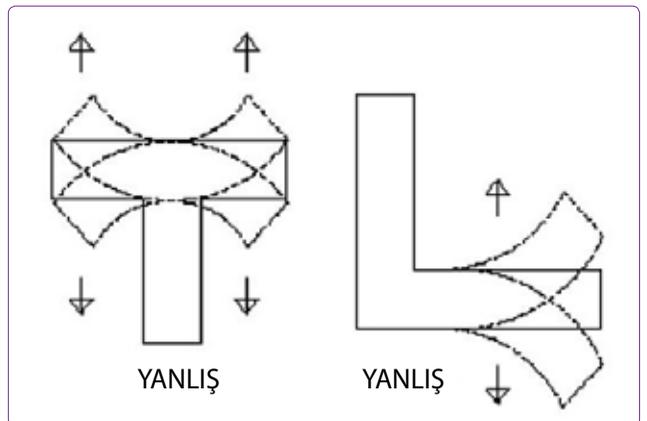
The architectural design of the structures to be built in earthquake zone must be developed in a way which prevents the impact of earthquake load. The forms in the shape of T and L, which are developed without implementation of dilatation joint cause the structures to be twisted and damaged during an earthquake (Figure 5).

Figure 5. The behaviour of T- and L- planned structures in the event of earthquake (Prepared by Author, 2012).

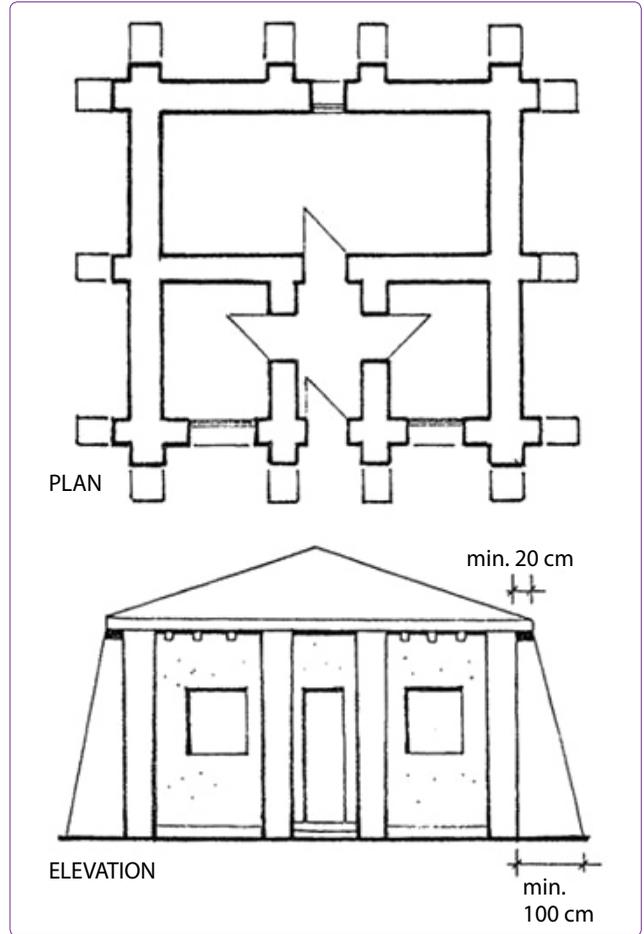
Additionally, the researchers pointed out that one of the most important damage reasons that had occurred in the rural masonry structures stemmed from weak vertices. Therefore various measures are needed to support the vertices. "The main reason of the collapse in masonry structures is that walls separate and they collapse with the roof. To prevent the structures from collapsing, support walls with props can be built at the connection and corner points of the walls".⁶ Technical analyses which investigated in pilot area determined that the problem of walls in the corners is one the most important causes of damage for the structures of pilot area. Figure 7 presents the details of props to be used in the structures.

Figure 7. Detail of props (Prepared by Author, 1993).

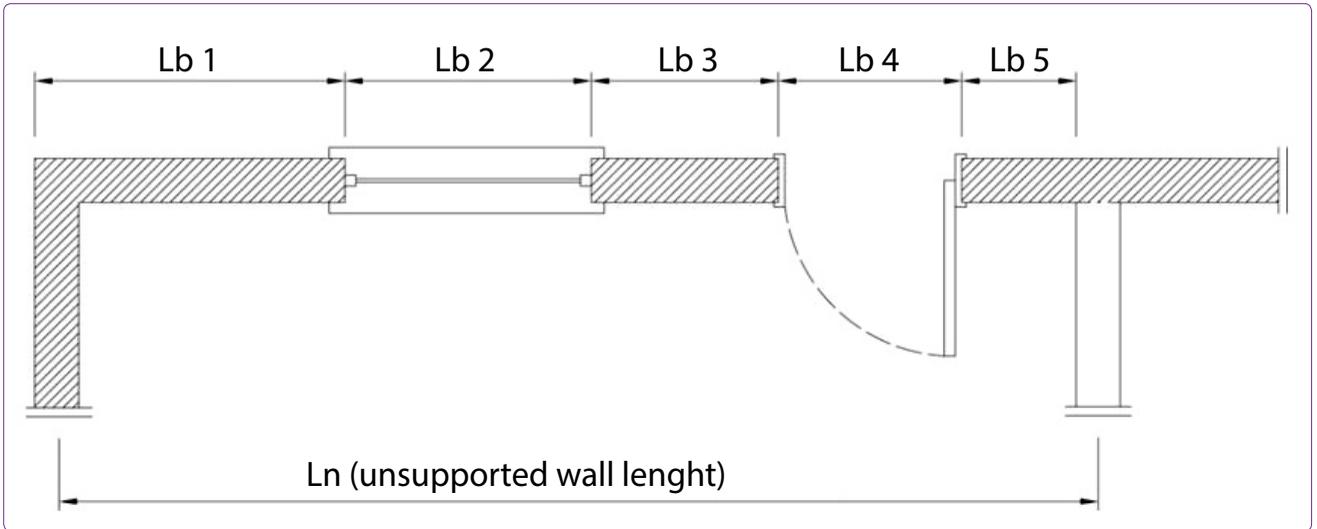
The voids in masonry walls and their proportions are highly important in the performance of the wall against earthquake. But the voids in masonry walls and their proportion of the pilot area are not suit-

able for the rules specified for walls and proportions in Earthquake Regulation 2007. Figure 9 presents the rules of the Earthquake Regulation 2007 specified for the proportion of voids and their locations in the walls.

Figure 9. The rules of the earthquake regulation specified for the proportion of voids and their locations in walls (Earthquake Regulation, 2007, p. 93).

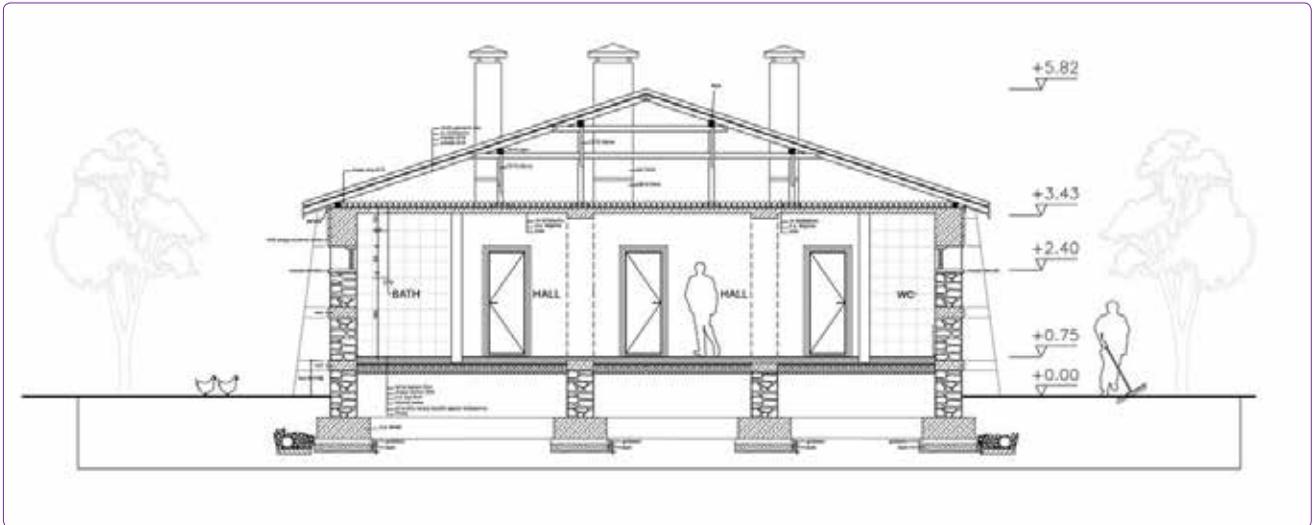
Figure 16. A section of suggested masonry house of pilot region with props and reinforced-concrete beams (Prepared by Author and members of Workshop, 2012).

the roof in farming. Figure 16 and 17 shows the section and a view of a masonry house which belongs to the pilot region with props and reinforced-concrete beams which has been improved during the study.

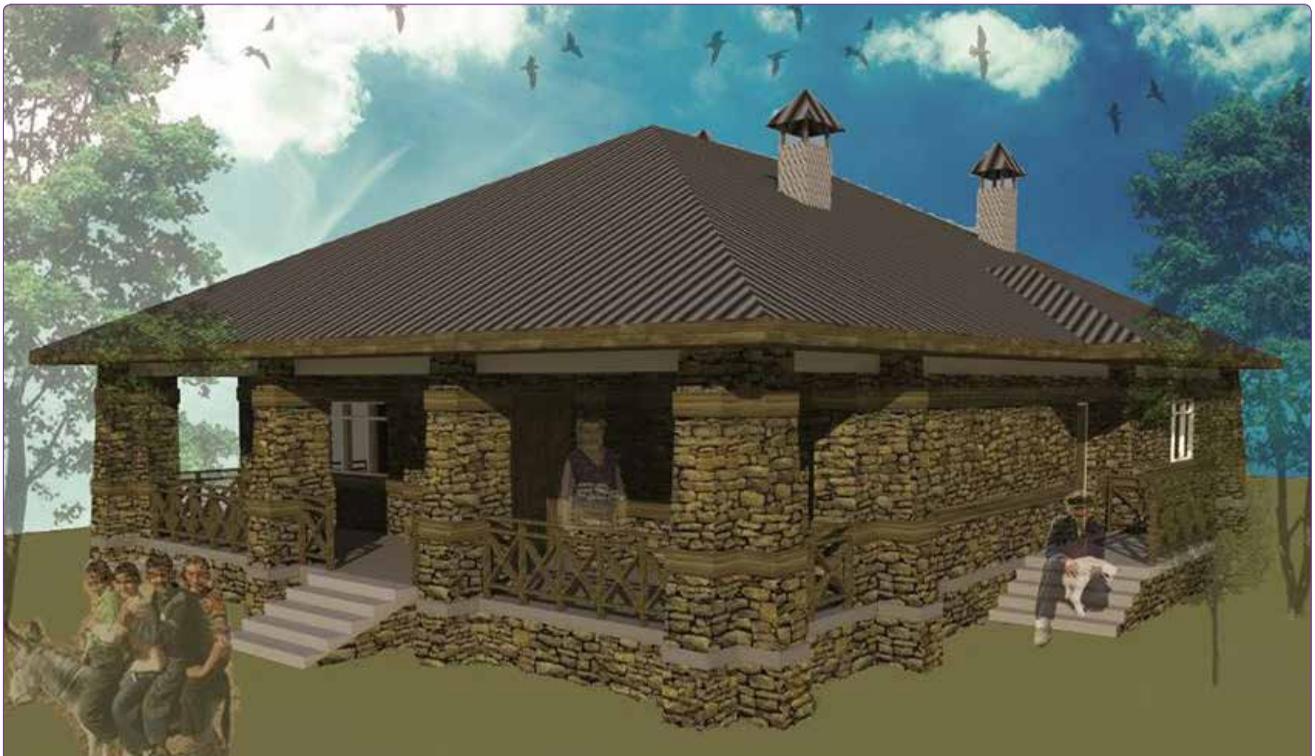
Figure 17. Suggested masonry house of pilot region with props and reinforced-concrete beams (Prepared by Author and members of Workshop, 2012).
