## Aortopulmonary fistula occurring 19 years after repair of aortic coarctation with Dacron patch aortoplasty

Ahmet Tayfun Gürbüz, M.D., Ali Can Vuran, M.D., Aydın Aytaç, M.D.

Department of Cardiovascular Surgery, Anadolu Sağlık Merkezi, Kocaeli

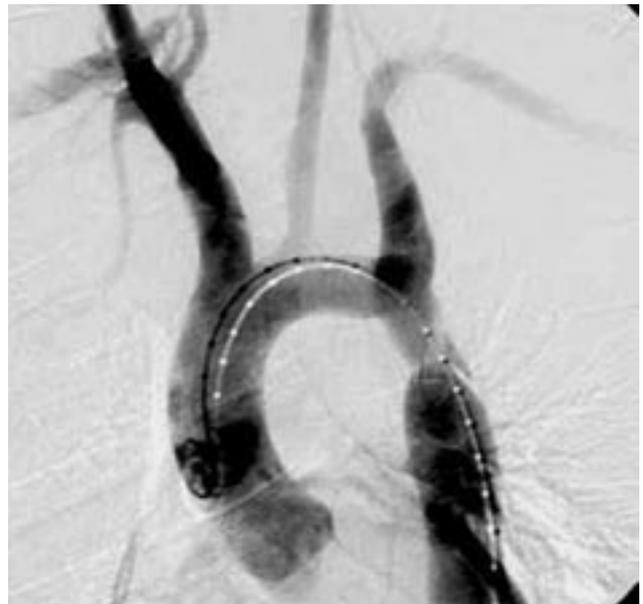
**Fig. 1.** Preoperative thoracic aortogram demonstrating recurrent coarctation at the site of Dacron patch aortoplasty and contrast extravasation through the patch.

of hemoptysis had progressively increased over the previous week, with a change in its character from blood-tinged sputum to large quantities of bright red blood. There was also a history of spontaneous efflux of bright red blood given off with Valsalva posturing. The only significant finding in the patient's history was aortic coarctation repair with the use of Dacron patch aortoplasty performed 19 years before. A thoracic aortogram was obtained which showed significant narrowing of the aortic lumen in the same location as well as a pressure gradient of 39 mmHg across the repair (Fig. 1). A small

amount of contrast material extravasation was also noted at the site of Dacron patch plasty. A diagnosis of recoarctation was made with a possible aortopulmonary fistula. Computed tomography (CT) angiography of the chest revealed obvious narrowing at the repair site as well as a double lumen appearance. However, a direct communication could not be demonstrated between the aorta and the pulmonary parenchyma. There was no evidence for a true aneurysm or pseudoaneurysm. Considering the presence of a significant pressure gradient and persistent hemoptysis with a possible etiology of aortopulmonary fistula, a decision of a redo coarctation repair was made.

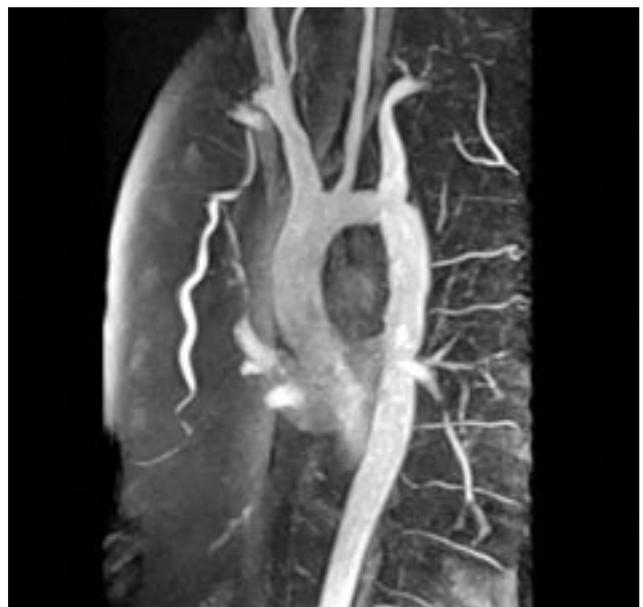
**Fig. 2.** Magnetic resonance angiography three months after the repair showing the new interposition graft.

day. Hemoptysis disappeared following the procedure. Magnetic resonance angiography performed three months after the repair showed no coarctation and a patent graft (Fig. 2).
