Twiddler's syndrome in an asymptomatic case *Semptomsuz bir olguda twiddler sendromu*

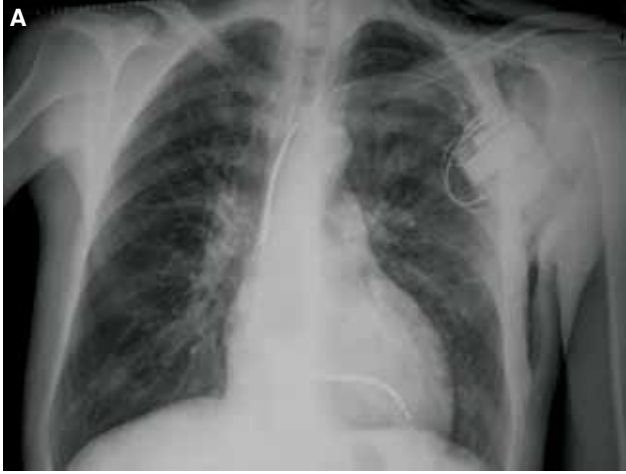
Figures. (A) The chest X-ray showing proper lead implantation. (B) Coiling of the pacing lead around the pulse generator. (C) Displacement of the lead to the subclavian vein.

implantation. A chest X-ray after implantation demonstrated proper lead position (Fig. A). One month after discharge, the patient was evaluated for pacemaker interrogation. Electrocardiography showed sinus rhythm with a heart rate of 80 beats per minute without any pacemaker spike. The interrogation revealed sense failure of the pacemaker. On the chest X ray, it was noted that the pacemaker lead twisted around the generator proximally, resulting in lead detachment from the cardiac chamber, and distal portion of the lead was placed in the subclavian vein (Fig. B, C). The patient had no symptoms, no mental disorder, and did not give any history of manipulation of the device pocket. He was not overweight and had a thin layer of subcutaneous tissue. The device pocket was opened, the lead was recoiled and replaced successfully, and the generator sutured into the muscle without any complications.
