## Crack Formation Following Root-End Preparation in Roots with the Butterfly Effect

**Objective:** To investigate apical cracks in roots that exhibit the butterfly effect and that have undergone apical resection and ultrasonic root-end cavity preparation. The effect of the obturation material was also studied.

Please cite this article as: Russell AA, Chandler NP, Friedlander LT. Crack formation following rootend preparation in roots with the butterfly effect. *Eur Endod J* 2018; 2: 107-12

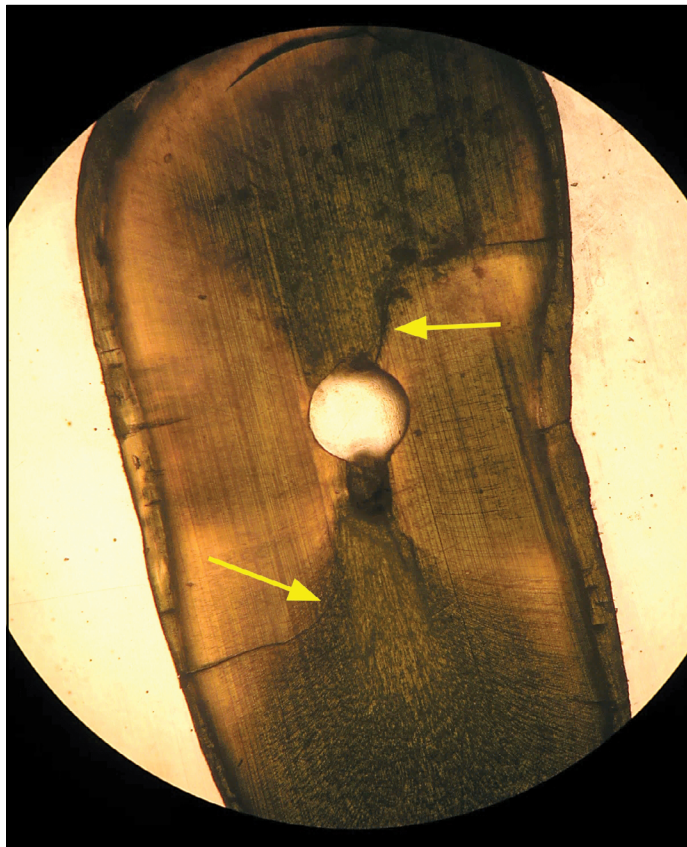
**Figure 1.** Root section (10×) under light microscope showing the butterfly effect  
Arrows indicate complete buccal and lingual cracks

A professional biostatistician was consulted and reviewed the study design. Power calculations were carried out to determine an appropriate sample size, which featured 80% power to detect differences. Ethical approval was granted from the University of Otago, Dunedin, New Zealand (reference H15/077), to collect 40 permanent, single-rooted maxillary human teeth of similar shape and size. Teeth with root resorption, immature apices, fracture, or a root filling were rejected. Teeth were washed and stored in phosphate buffered saline (PBS, pH 7.4) until required. Teeth were decoronated at the cemento-enamel junction with a diamond bur under constant water irrigation. Roots were viewed under a light microscope (EHT; Olympus, Tokyo, Japan) at 10× magnification and coded as “B” butterfly or “NB” non-butterfly on the basis of the presence or absence of the effect (Fig. 1).

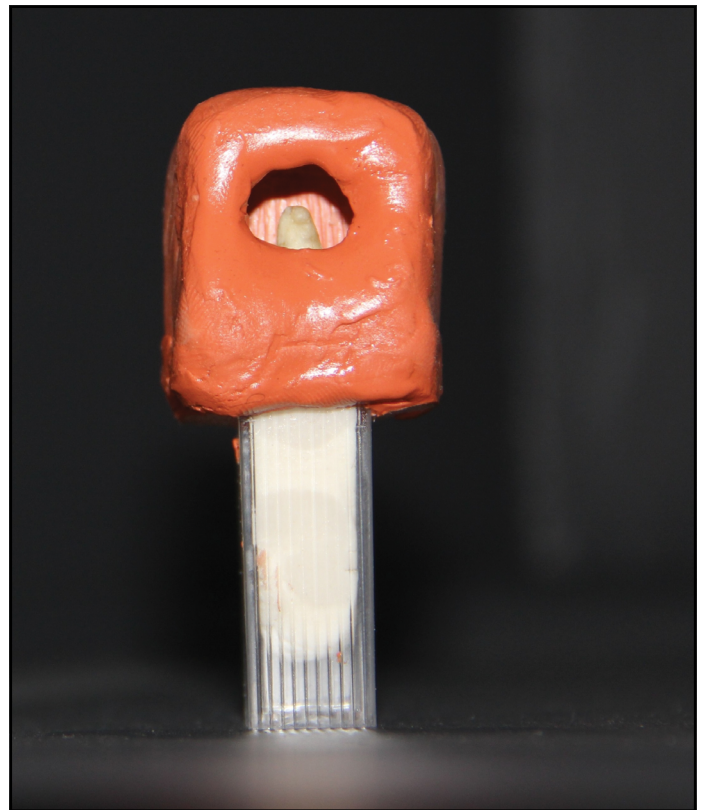
**Figure 2.** Simulated bony crypt used for resection and root-end preparation

Italiana SpA, Milan, Italy) such that the apical third extended beyond the cuvette to allow access for resection. A silicone stent was made to simulate a bony crypt and mimic a limited degree of visual and surgical access (Fig. 2). All preparations were done by a single operator using a dental operating microscope (DOM; OPMI pico, Carl Zeiss Ltd, Oberkochen, Germany) at 6× magnification within the crypt simulator. Roots were resected perpendicular to their long axis, 3 mm from the apex, using a high-speed tungsten carbide surgical bur (H162, Komet, Gebr. Brasseler, Lemgo, Germany) under copious water irrigation. Root-ends were polished with an ultra-fine 30-fluted composite finishing bur (H135UF, Komet). They were then inspected for cracks using DOM at 10× magnification.

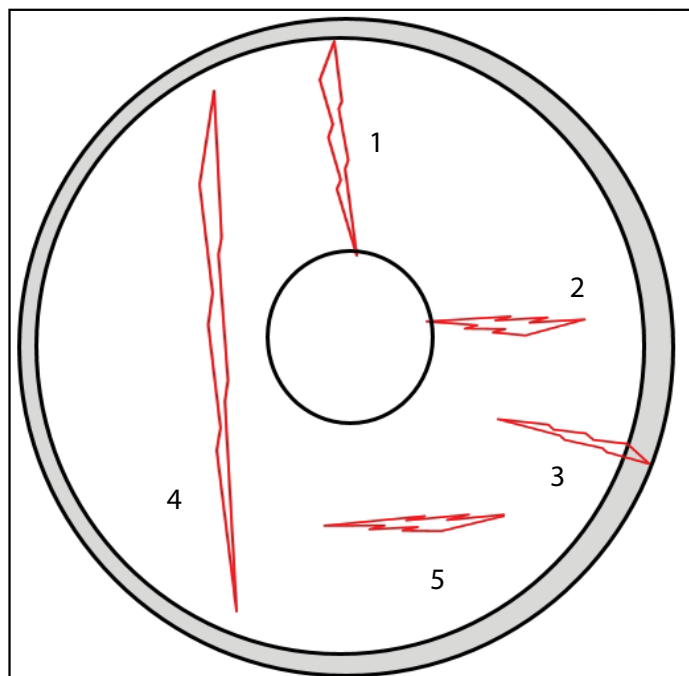
**Figure 3.** Crack classification following ultrasonic preparation (modified from Layton et al. 1996)

was under consideration. Cracks were recorded according to a modified version of the classification provided by Layton et al. 1996 (9) (Fig. 3). A superimposed grid was used to standardize crack direction records (Fig. 4). Observers viewed the images on their own computers following familiarization using example micrographs.

Crack Class	Description
1. Complete canal	Crack emerges from the canal space and extends to the outer root surface.
2. Incomplete canal	Crack emerges from the canal space and extends partially into the radicular dentine but ends short of the external root surface.
3. Cemental	Crack radiating from the cemental surface to the cementodentinal junction and into the dentine.
4. Intradentine BL	Crack confined to the dentine and runs in a buccolingual direction, mesial or distal to the canal.
5. Intradentine MD	Crack confined to the dentine and runs in a mesiodistal direction, either buccal or lingual to the canal.

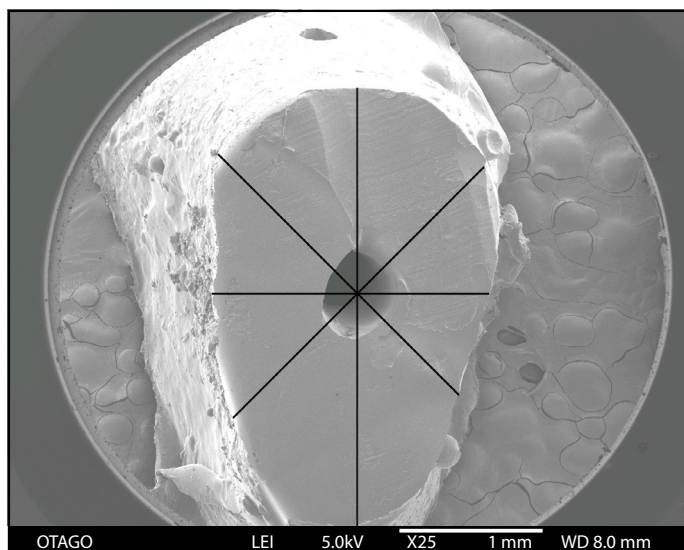
**Figure 4.** SEM image (25×) of a resin replica of a root end showing assessment grid

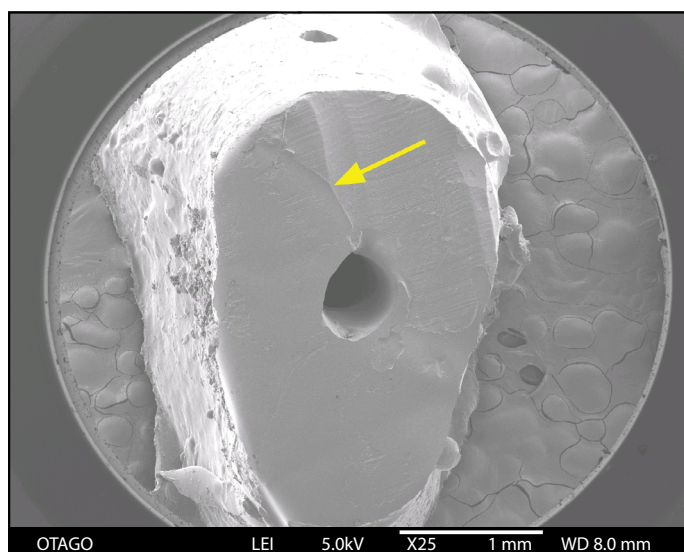
**Figure 5.** SEM image (25×) of a resin replica of a root end showing a buccal crack (arrow)

An example of apical cracks in a tooth with the butterfly effect is shown in Fig. 5, and SEM results appear in Tables 1 and 2. None of the teeth developed cracks during root-end resec-
